# FULL RESERVE STUDY

## Phoenix On The Bay II Owners Association, Inc.

**Orange Beach, Alabama**

**March 15, 2017**

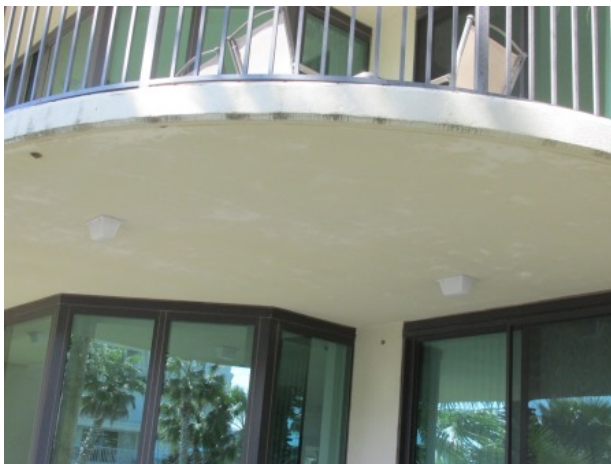
**Condition:** Good overall with finish deterioration, isolated cracks and exposed reinforcement evident.

**Balcony finish deterioration**

**Useful Life:** Capital repairs including a close-up visual inspection, patching of delaminated concrete, routing and filling of cracked concrete, replacement of tile floor coverings and waterproof coating applications up to every 25 years.

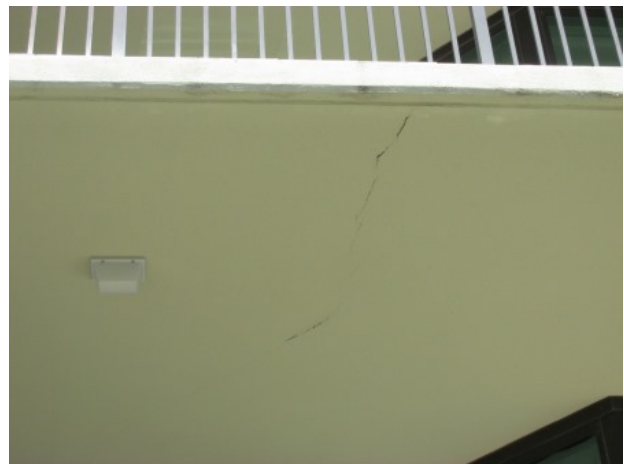
**Crack at balcony underside**

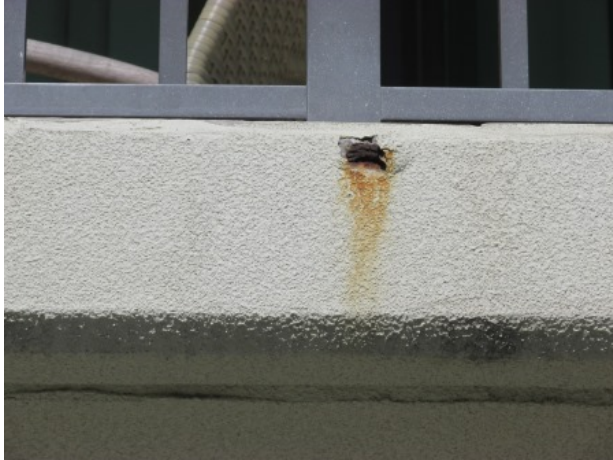
**Exposed reinforcement at balcony edge**

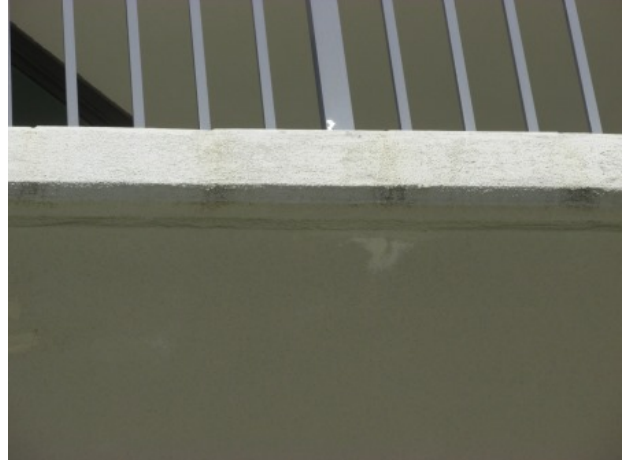
**Balcony finish deterioration**

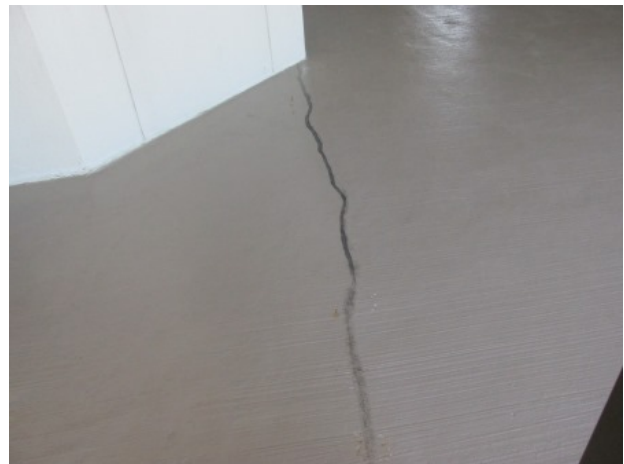
**Condition:** Good to fair overall with cracks and finish deterioration evident.

**Breezeway crack**

**Useful Life:** Capital repairs including a close-up visual inspection, patching of delaminated concrete, routing and filling of cracked concrete, and waterproof coating applications every six- to eight-years.

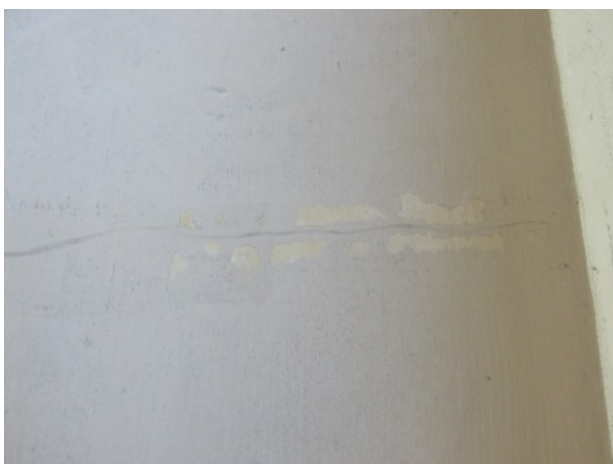
**Breezeway crack and finish deterioration**

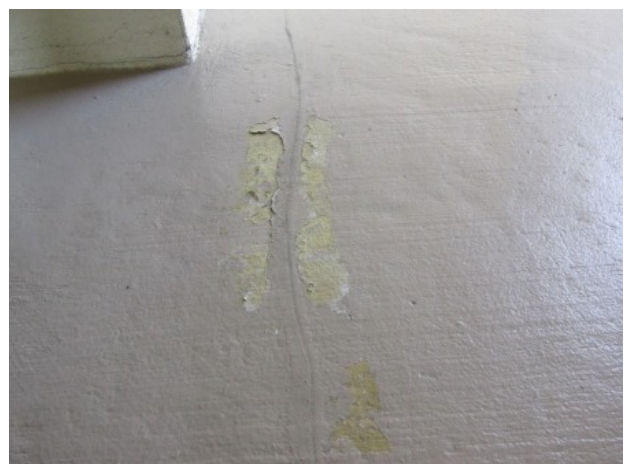
**Breezeway crack and finish deterioration**

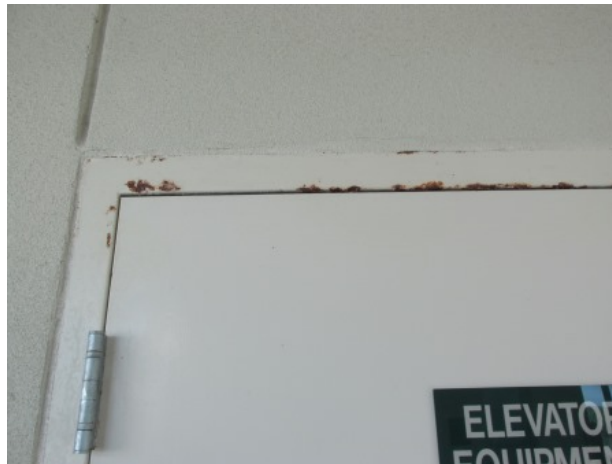
**Condition:** Good overall with isolated rust evident.

**Isolated rust at common door**

**Expenditure Detail Notes:** Expenditure timing and costs are depicted in the **Reserve Expenditures** table in Section 3. We recommend the Association fund touch-up paint to limit rust through the operating budget.

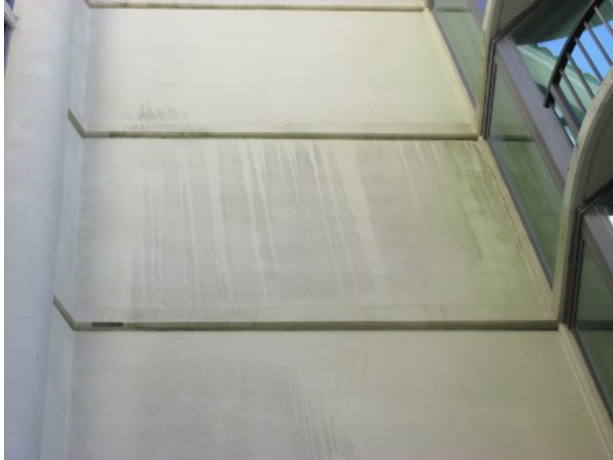
**Condition:** Fair overall with biological growth, and isolated cracks evident.

**Stucco paint finish biological growth**

**Useful Life:** We recommend inspections, repairs and paint finish applications every five- to seven-years.

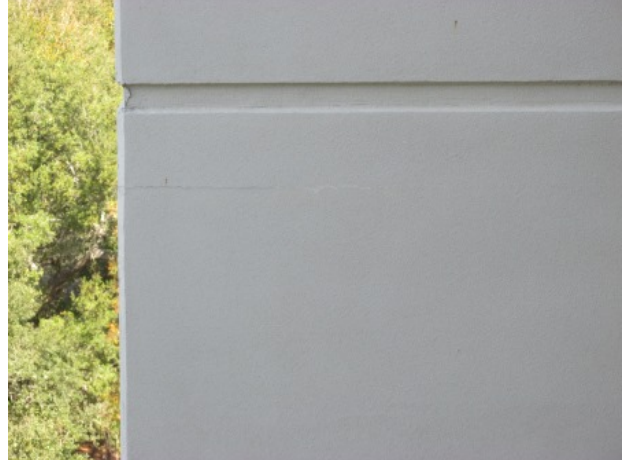
**Stucco crack**

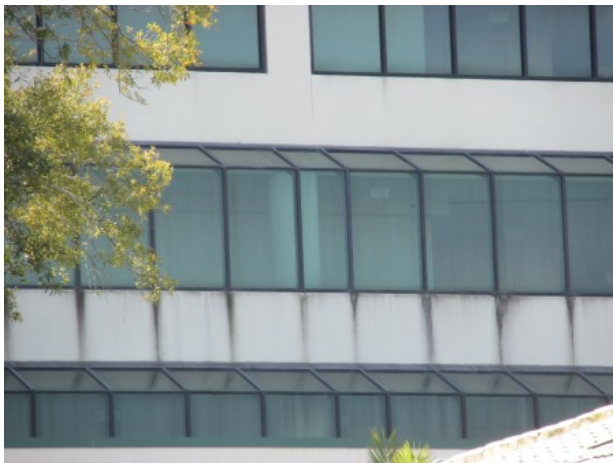
**Stucco paint finish biological growth**

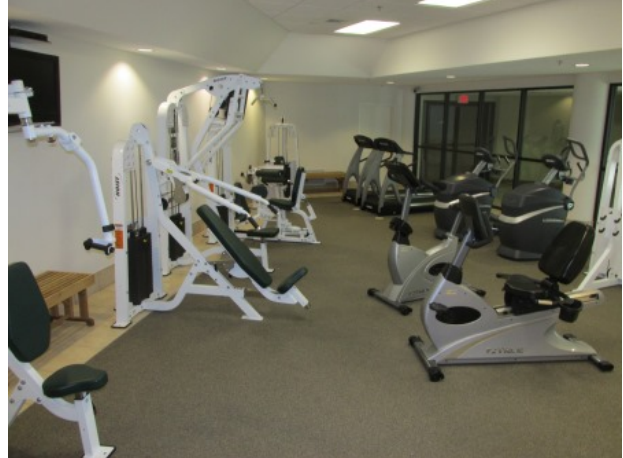
**Exercise room carpet – note stains**

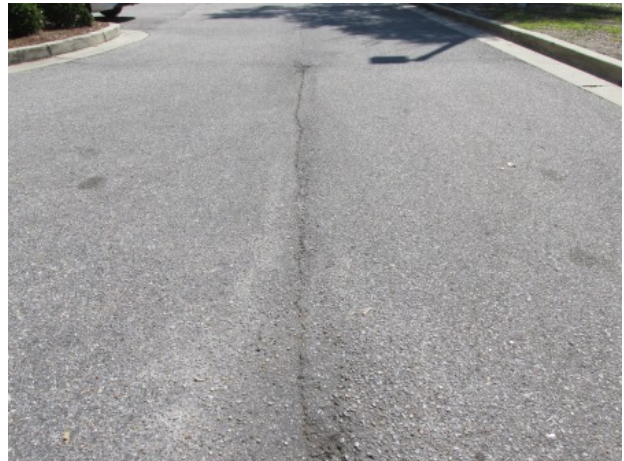
**Condition:** Good overall with isolated cracks evident

Centerline crack

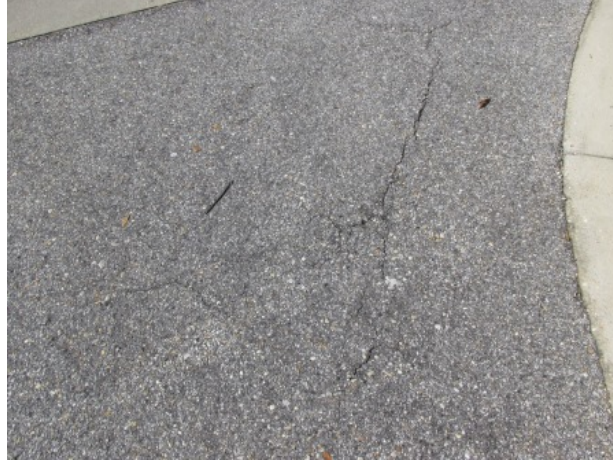
**Minor asphalt pavement cracks**

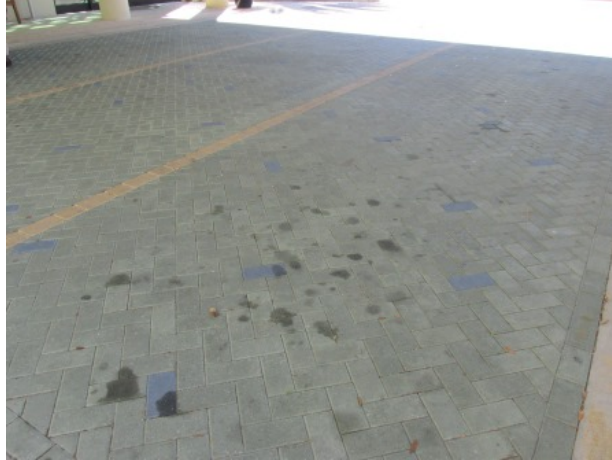
**Condition:** Good to fair overall with vehicular stains evident

**Masonry pavers at the porte cochere**

**Expenditure Detail Notes:** Expenditure timing and costs are depicted in the **Reserve Expenditures** table in Section 3. We suggest the Association conduct interim resetting

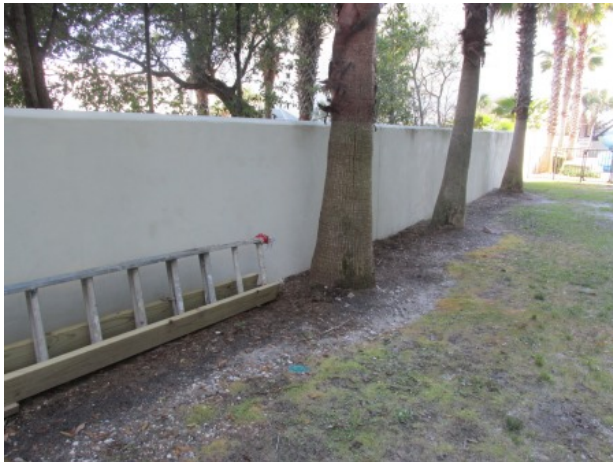
**Condition:** The walls are in fair condition overall. We note settlement of localized sections of the wall near the northeast corner of the pool area. The paint finish is in fair condition overall.

**Perimeter wall overview**

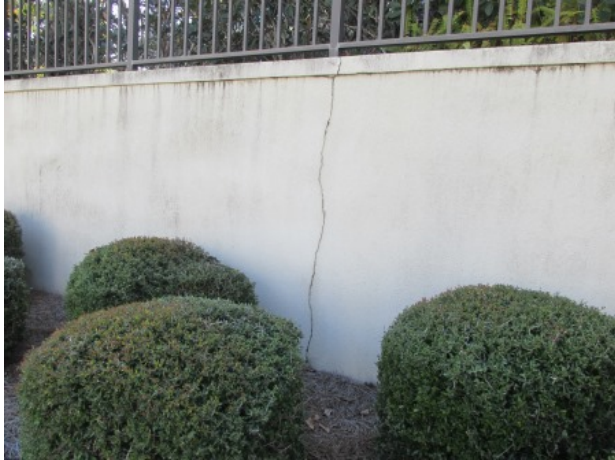
**Condition:** Good to fair overall with isolated cracks evident

Retaining wall crack

**Useful Life:** Concrete retaining walls have indeterminate useful lives. However, we recommend the Association plan for inspections and capital repairs every five- to seven-years to forestall deterioration.

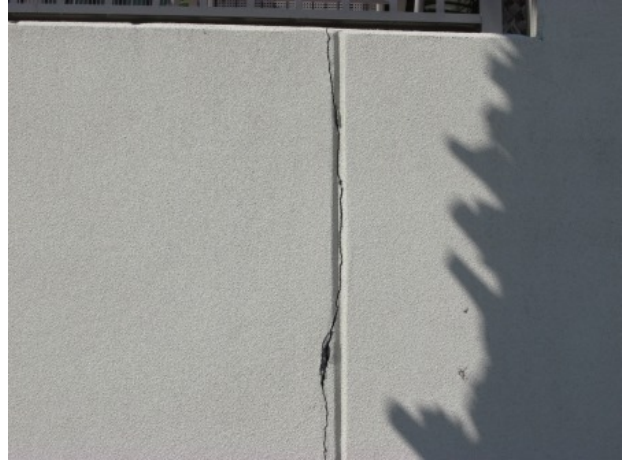
Retaining wall crack

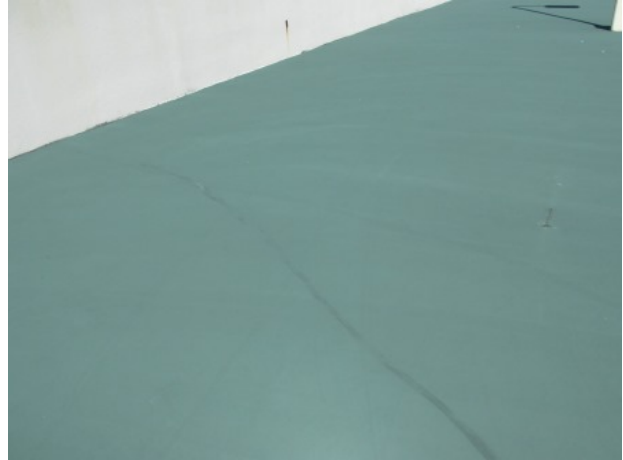
**Isolated crack**

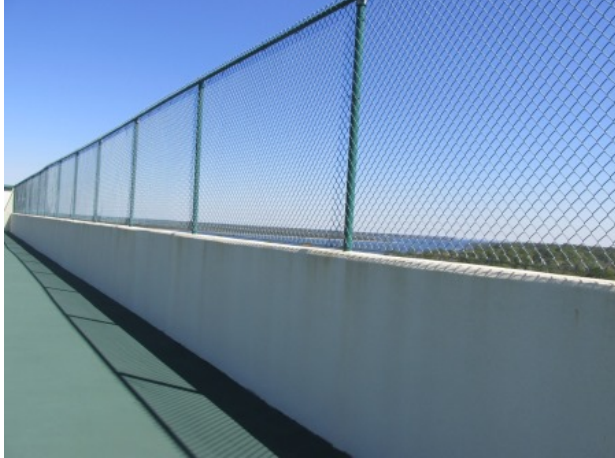
**Condition:** Good overall with fastener deterioration evident

**Tennis court fence**

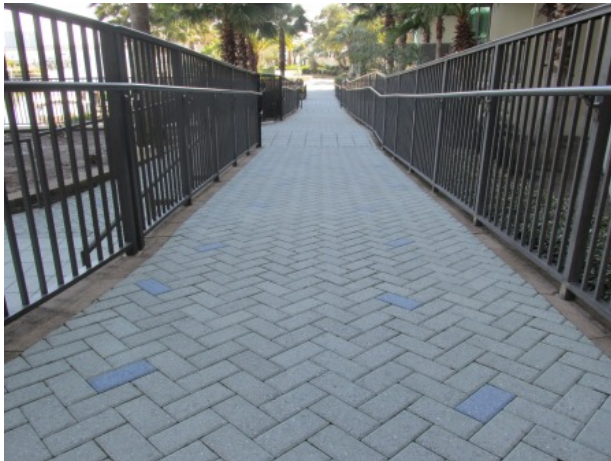
**Condition:** Good condition with isolated settlement evident

Masonry deck pavers

**Useful Life:** The pavers have a useful life of up to 30 years. Soil movement and water infiltration underneath the pool decks can cause significant settlement of the surrounding pavers. The pool deck should also be free of trip hazards for the safety of residents and their guests.

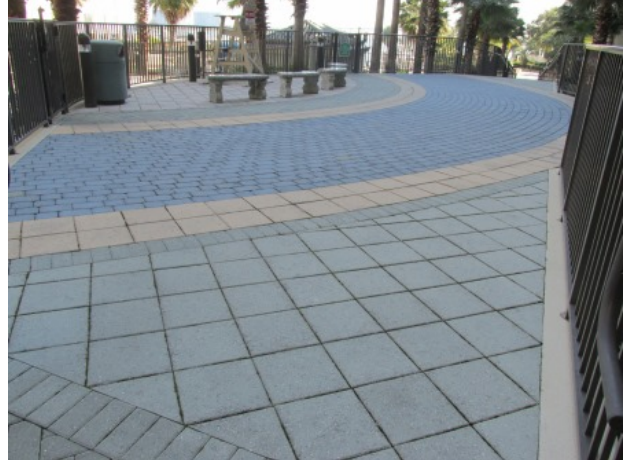
**Masonry deck pavers**

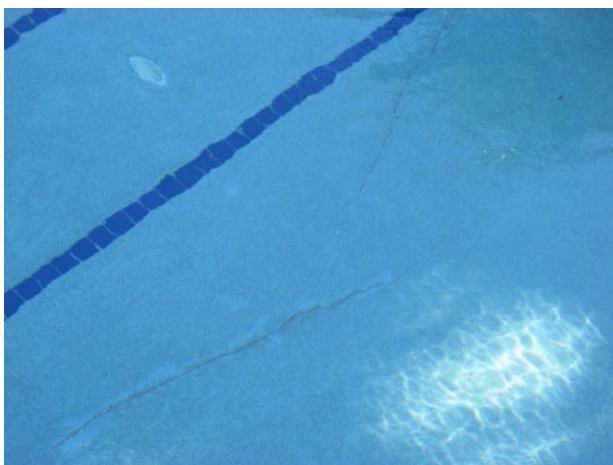
- Bird pool and lazy river – Fair overall. We note cracks throughout the lazy river
- Outdoor kiddie pool and indoor spas – Good overall
- Indoor pool – Good to fair overall with isolated discoloration

**Lazy river plaster cracks**

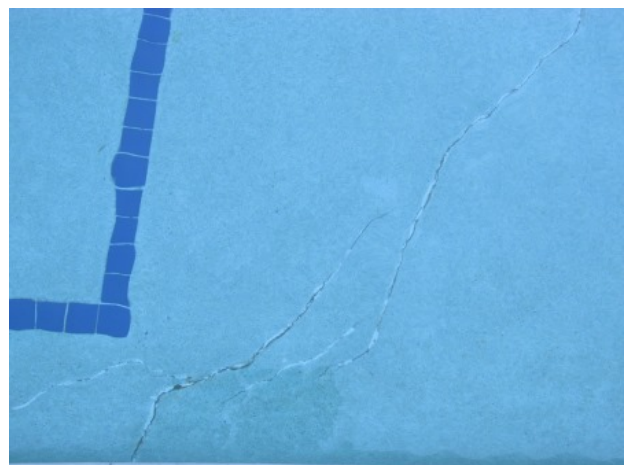
**Lazy river plaster cracks**

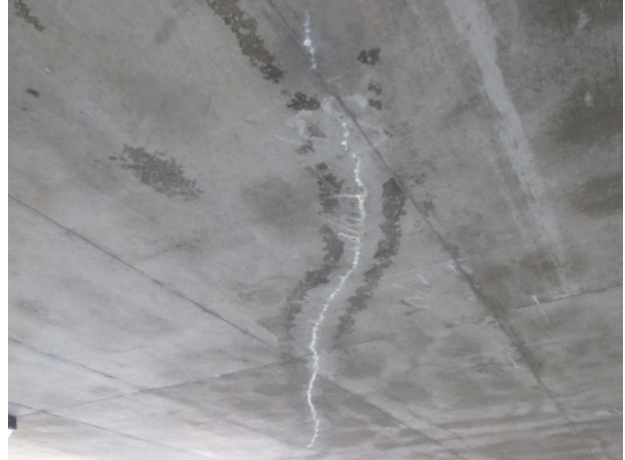
**Condition:** Good to fair overall with exposed reinforcing steel and isolated stalactites evident. The elevated structural concrete does not utilize a protective traffic coating.

**Crack on ceiling**

**Useful Life:** Repairs to the various concrete surfaces every 10- to 15-years

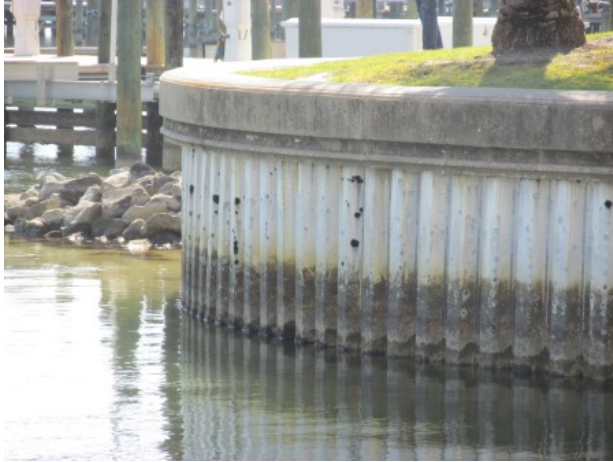
**Conditions:** The steel bulkheads are in fair condition with widespread holes evident. The vinyl bulkheads are in good overall condition.

**Steel bulkhead**

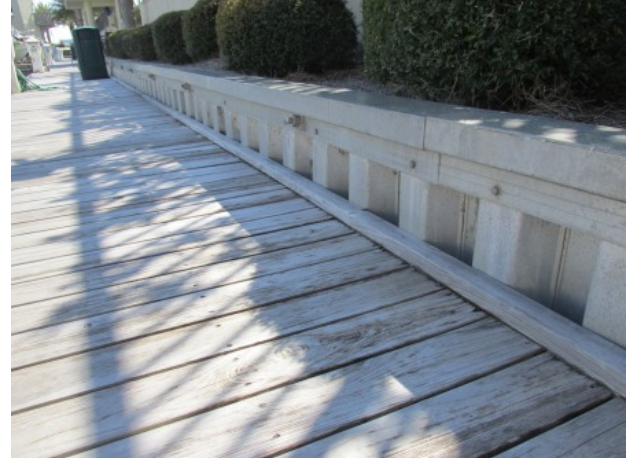
**Old steel bulkhead**

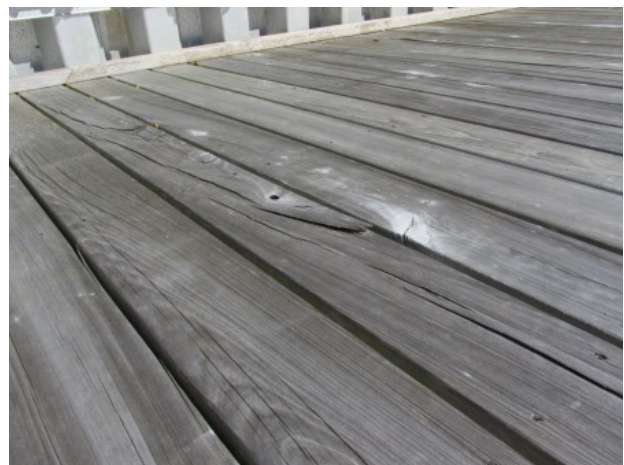
**Condition:** Good condition minor weathered boards

**Weathered deck boards**

**Useful Life:** Up to 30 years with deck board replacements every 15 years.
