Phoenix On The Bay II Owners Association, Inc.

Orange Beach, AL • December 9, 2022

RESERVE STUDY

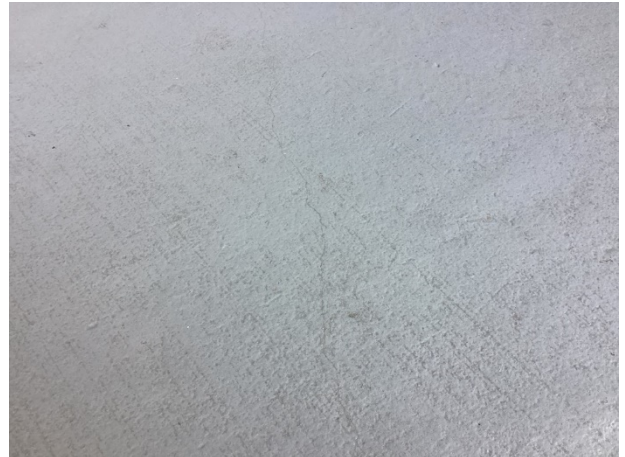
Condition: The balconies are in good overall condition and the breezeways are in good to fair overall condition with isolated cracks and chipped coatings evident

Concrete cracks

Useful Life: Capital repairs including a close-up visual inspection, patching of delaminated concrete, routing and filling of cracked concrete, and waterproof coating applications up to every 25 years for the balconies due to the presence of tile floor coverings and every six- to eight-years for the breezeways.

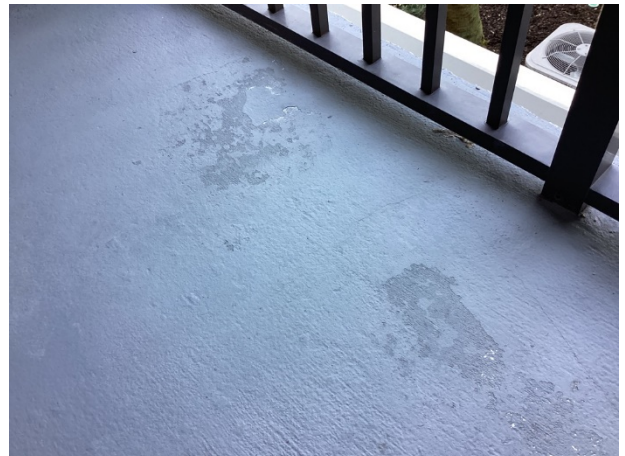
Evidence of isolated chipped coatings

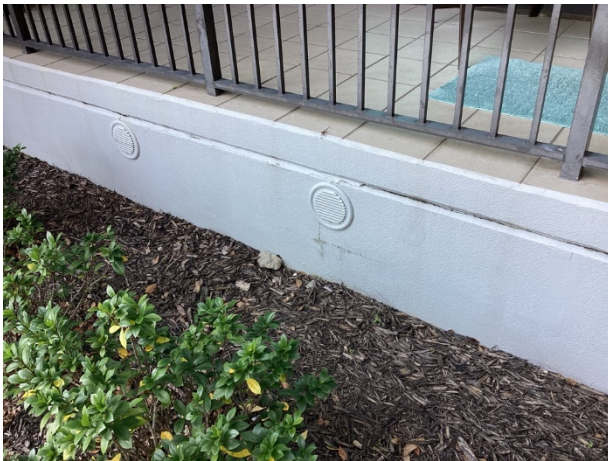
Condition: Good to fair overall with isolated cracks evident.

Stucco cracks

Useful Life: We recommend inspections, repairs and paint finish applications every five- to seven-years.

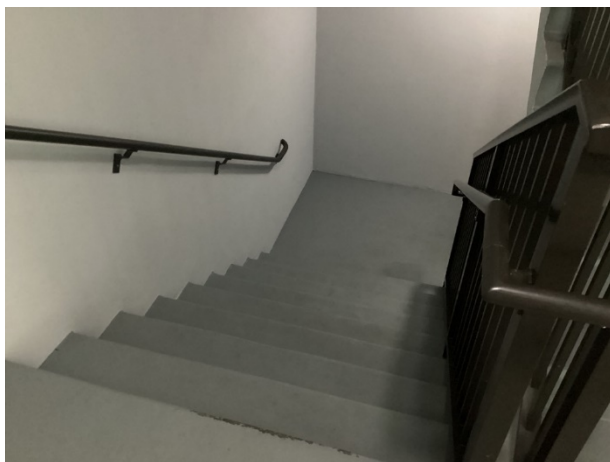
Conditions: Good to fair overall with scuffs evident.

Stairwell paint finishes

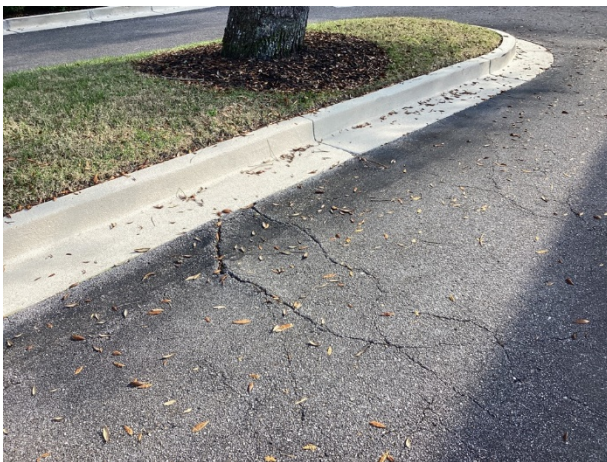
Condition: Good to fair overall with isolated cracks and settlement evident. We note centerline deterioration at the pavement due to the drainage system.

Pavement cracks due to tree root uplift

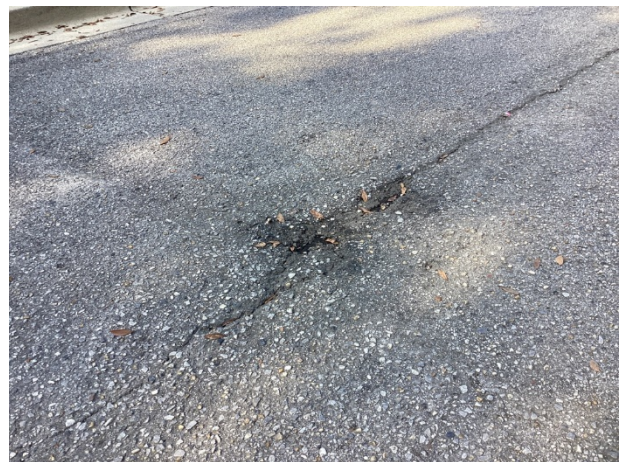
Pavement settlement

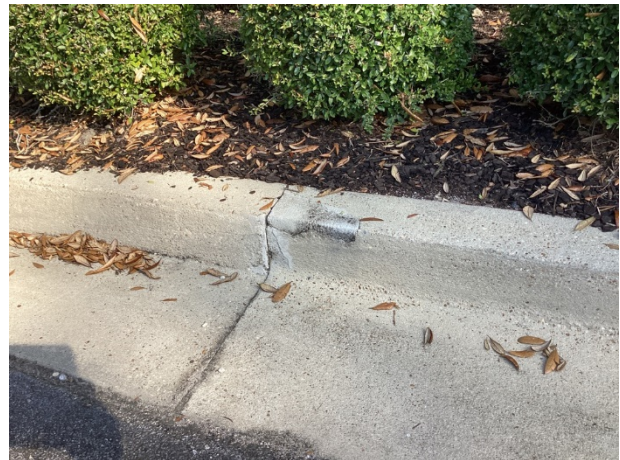
Condition: Good to fair overall with isolated cracks evident.

Concrete cracks

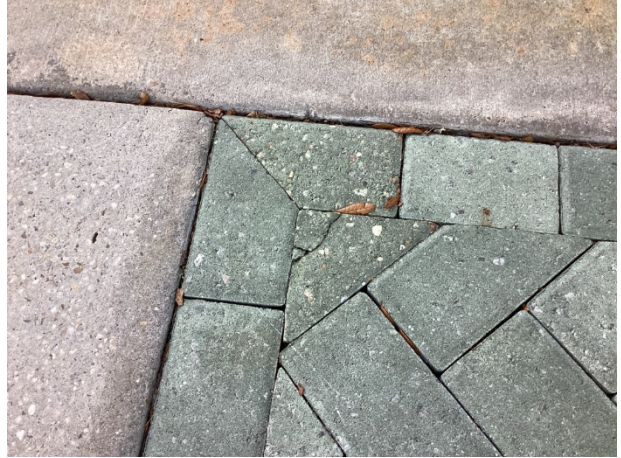
Condition: Good to fair overall

Paver cracks

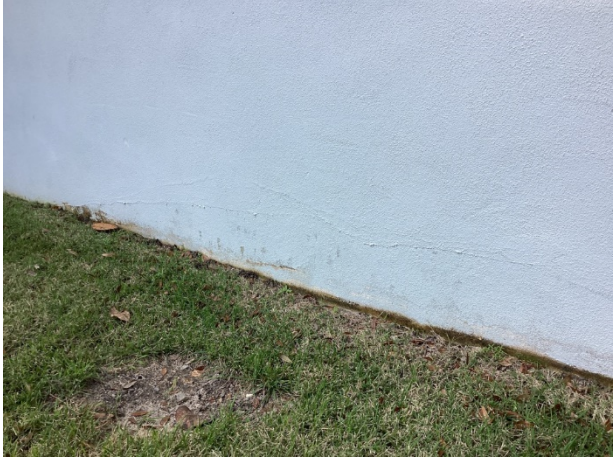
Condition: The walls are in good to fair condition overall and paint finish is in good to fair condition overall with isolated cracks evident.

Wall stucco cracks

Useful Life: Indefinitely long with periodic finish applications and proper maintenance every six- to eight-years

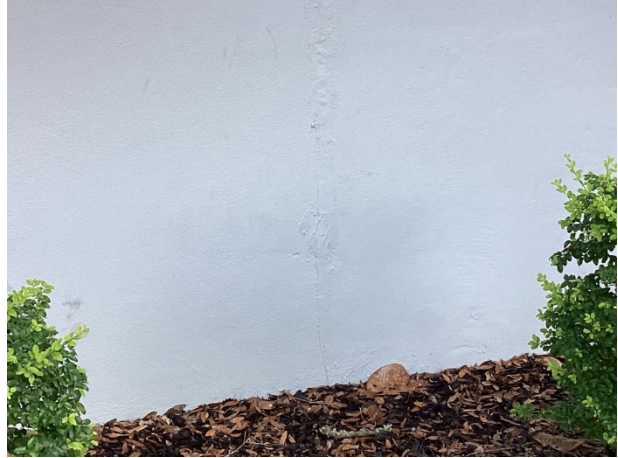
Wall stucco cracks

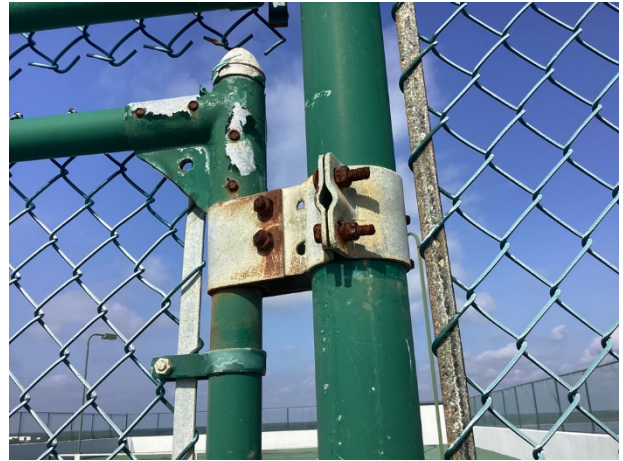
Condition: Good to fair overall with rust evident.

Fence post rust

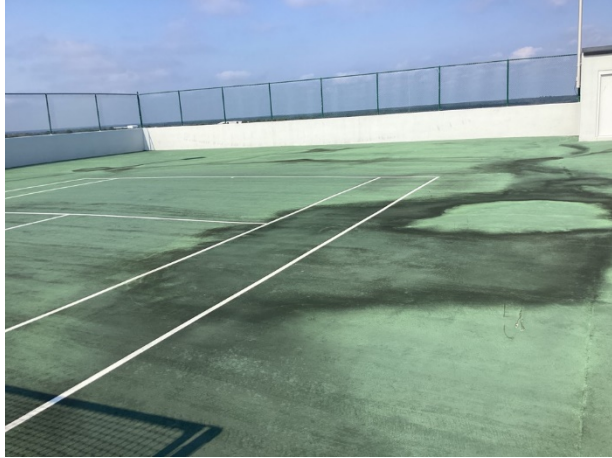
Condition: Fair overall with isolated color coat fade, chipped waterproof coatings and cracks

Color coat fade

Useful Life: Six- to eight-years

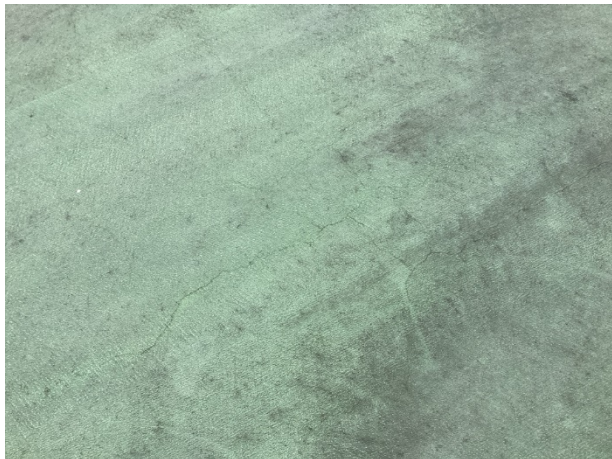
Surface cracks

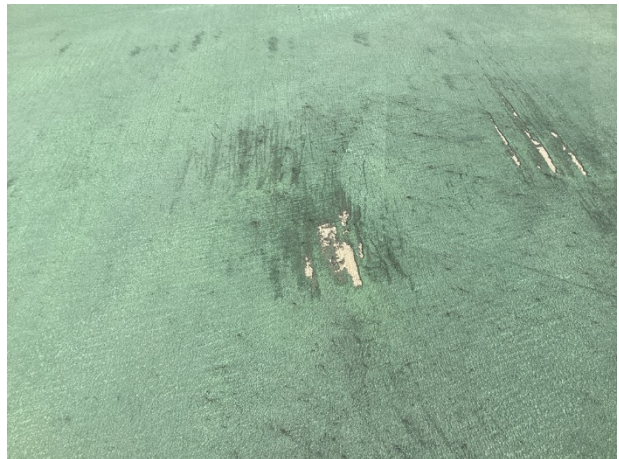
Chipped waterproof coatings

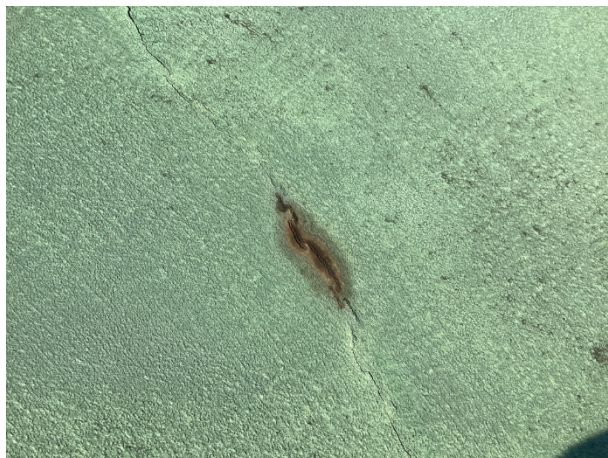
Surface cracks

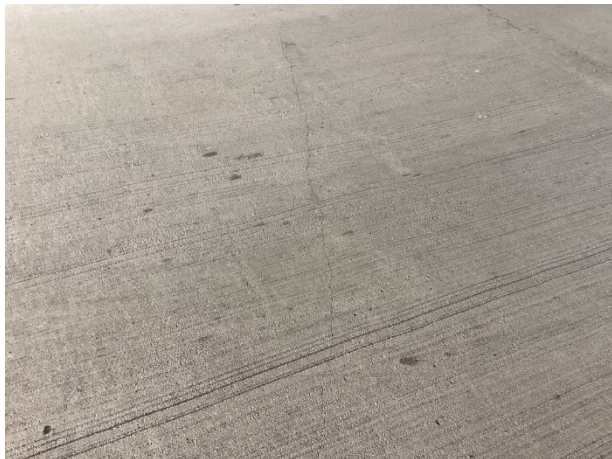
Condition: Good to fair overall with isolated cracks and exposed reinforcing steel evident. The elevated structural concrete does not utilize a protective traffic coating

Concrete cracks

Useful Life: Repairs to the various concrete surfaces every 5- to 10-years

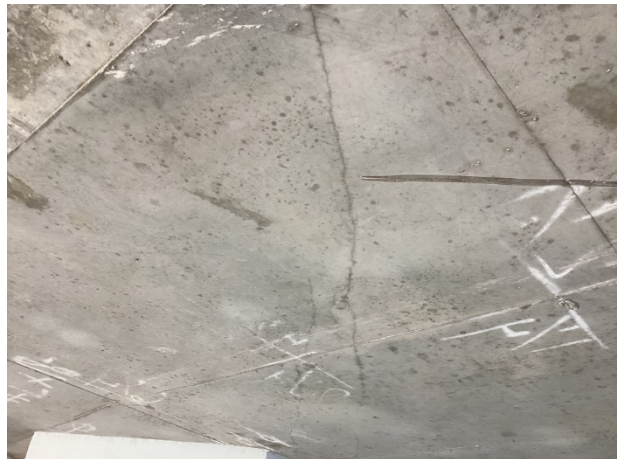
Concrete cracks at ceiling

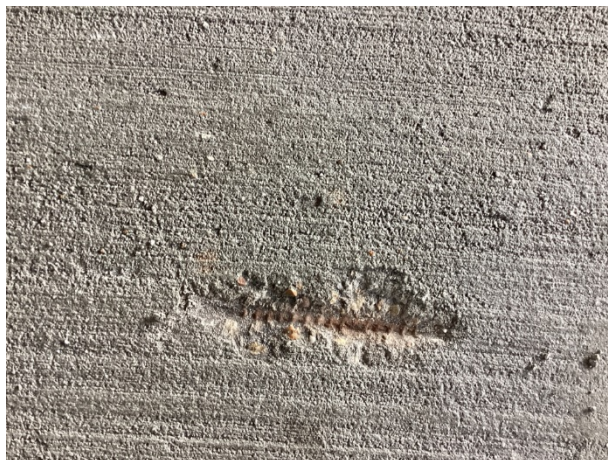
Exposed reinforcement
