# FULL RESERVE STUDY

## Phoenix On The Bay II Owners Association, Inc.

**Orange Beach, Alabama**

**March 15, 2017**

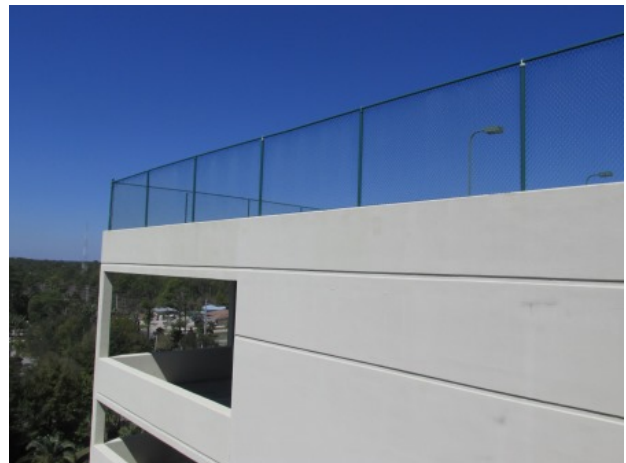
**Parking garage stucco paint finish**

**Useful Life:** We recommend inspections, repairs and paint finish applications every five- to seven-years.

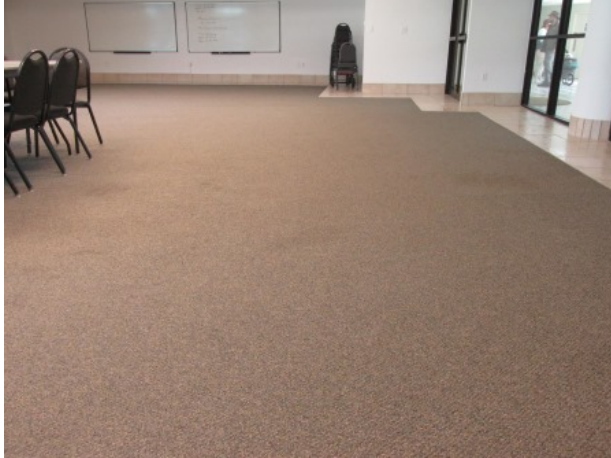
**Condition:** Fair overall with stains evident

**Meeting room carpet – note stains**

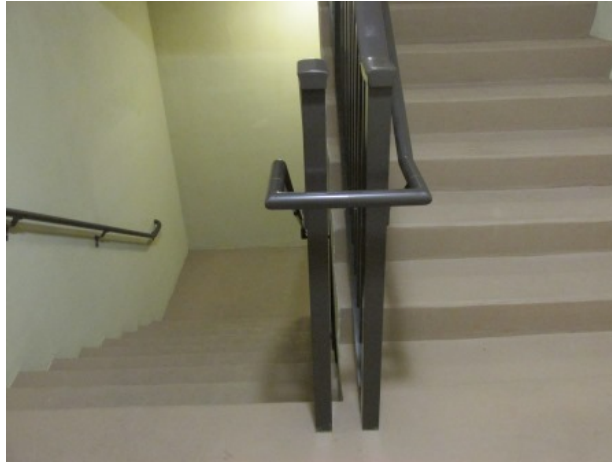
**Conditions:** Good overall

**Stairwell paint finishes**

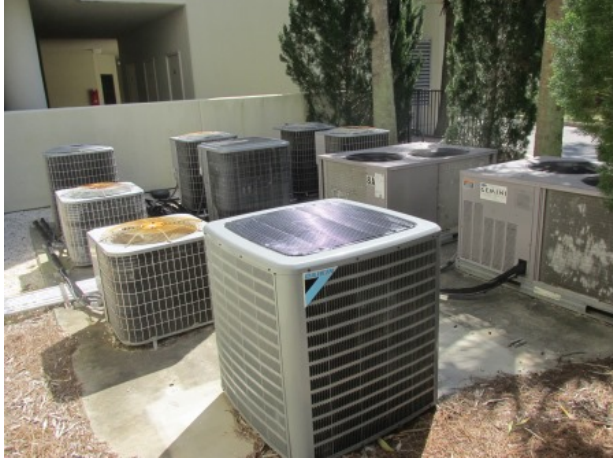
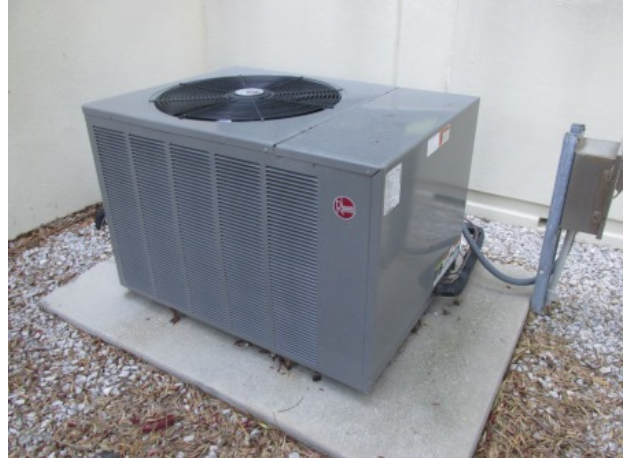
**Condition:** Reported satisfactory

**Split system condensing units**

**Split system condensing unit**

**Expenditure Detail Notes:** Expenditure timing and costs are depicted in the **Reserve Expenditures** table in Section 3. The condensing unit may require replacement prior to replacement of the related interior forced air unit. For purposes of this Reserve Study, we assume coordination of replacement of the interior forced air unit, evaporator coil, refrigerant lines and exterior condensing unit. We recommend the Association budget for replacement of up to fifty percent (50%) of the systems with each event.

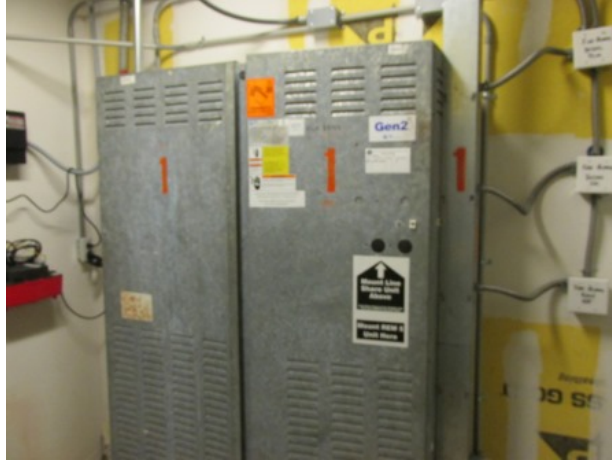
**Condition:** Reported satisfactory

**Typical elevator equipment**

**Expenditure Detail Notes:** Expenditure timing and costs are depicted in the **Reserve Expenditures** table in Section 3. We anticipate replacement of the following traction elevator system components:

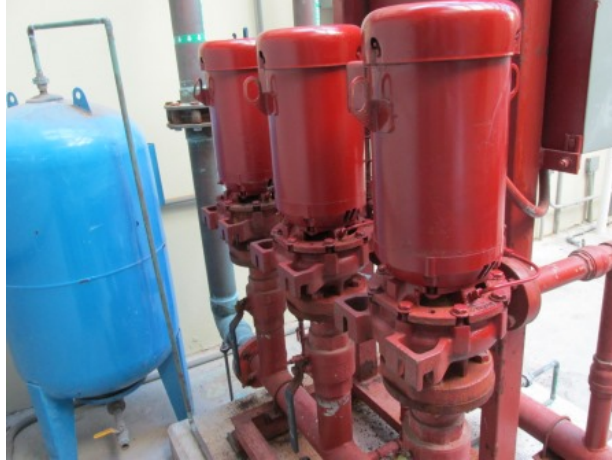
- Domestic cold water - 7.5-HP, three each, original, reported satisfactory

**Domestic water pumps**

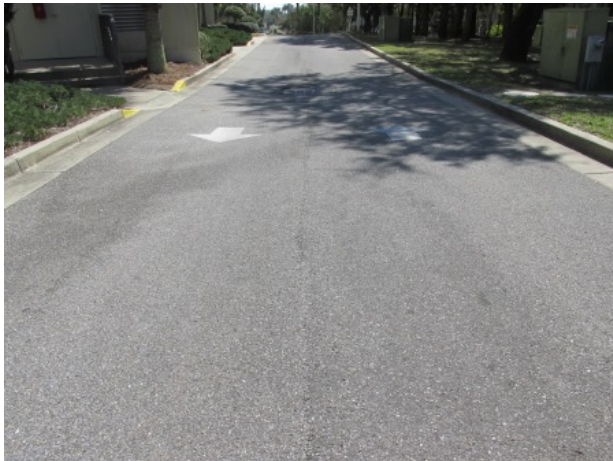
Asphalt pavement overview

**Condition:** Good overall with isolated cracks evident

followed by the application of two or more new lifts of asphalt. We recommend mill and overlayment on asphalt pavement that exhibits normal deterioration and wear. We recommend total replacement of asphalt pavement that exhibits severe deterioration, inadequate drainage, pavement that has been overlaid multiple times in the past or where the configuration makes overlayment not possible. Based on the apparent visual condition and configuration of the asphalt pavement, we recommend the mill and overlay method of repaving at Phoenix On The Bay II.

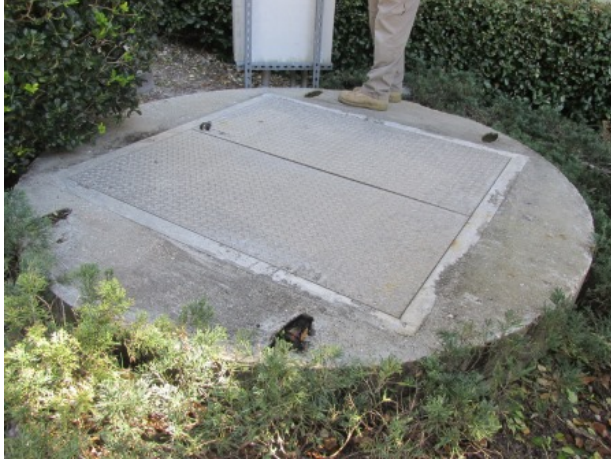
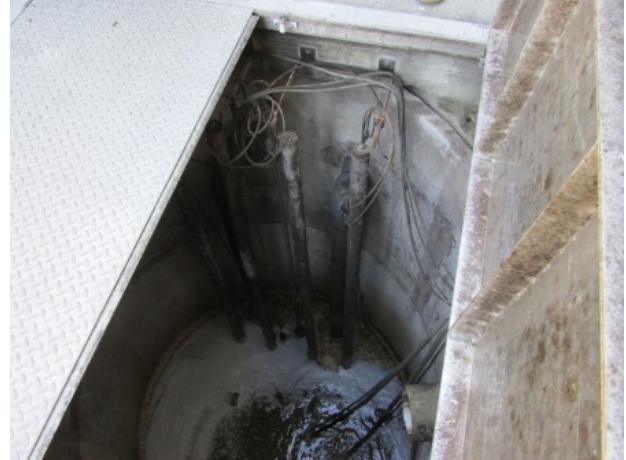
Lift station top

**Condition:** Reported good overall without any reports of service interruptions

**Expenditure Detail Notes:** Expenditure timing and costs are depicted in the **Reserve Expenditures** table in Section 3. Rebuilding of the station includes replacement of pumps, motors, guide rails and electrical components including controls. The Association should fund interim repairs and replacements through the operating budget.

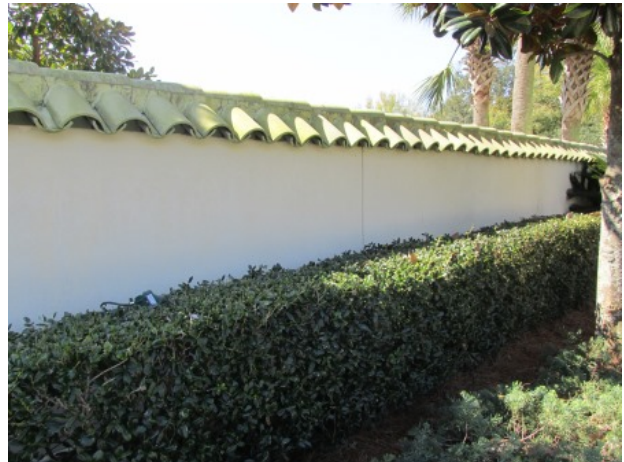
**Condition:** The walls are in fair condition overall. We note settlement of localized sections of the wall near the northeast corner of the pool area. The paint finish is in fair condition overall.

**Perimeter wall near entrance**

**Expenditure Detail Notes:** Expenditure timing and costs are depicted in the **Reserve Expenditures** table in Section 3. Our estimate of cost anticipates repair or replacement of up to one percent (1%), of the stucco and up to ten percent (10%) of the concrete coping tile near the main entrance in coordination with each paint finish application. The exact amount of area in need of repair will be discretionary based on the actual future conditions and the desired appearance. Each paint product has the limited ability to cover and seal cracks but we recommend repair of all cracks which exceed the ability of the paint product to bridge.

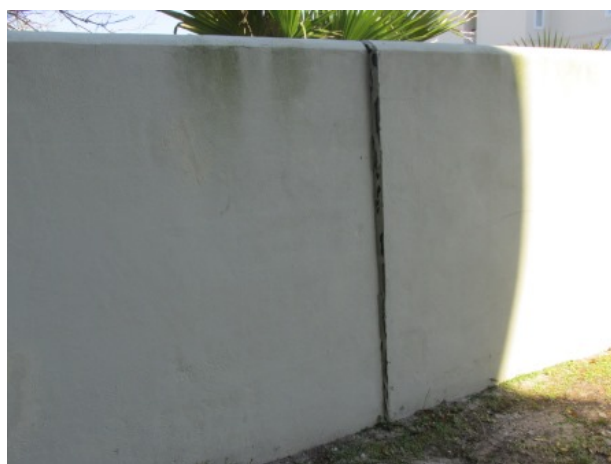
**Settled perimeter wall section**

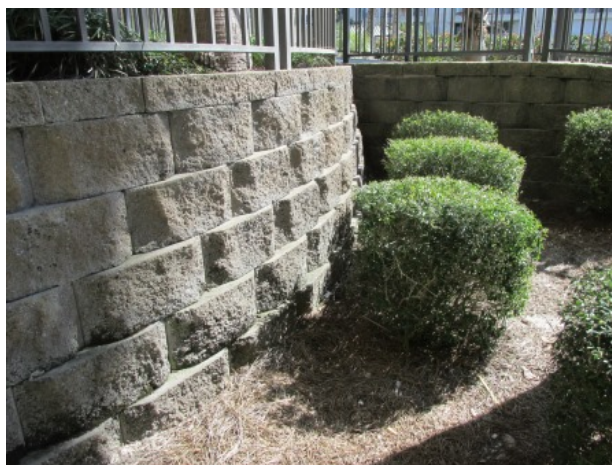
Masonry retaining wall

**Condition:** Good overall

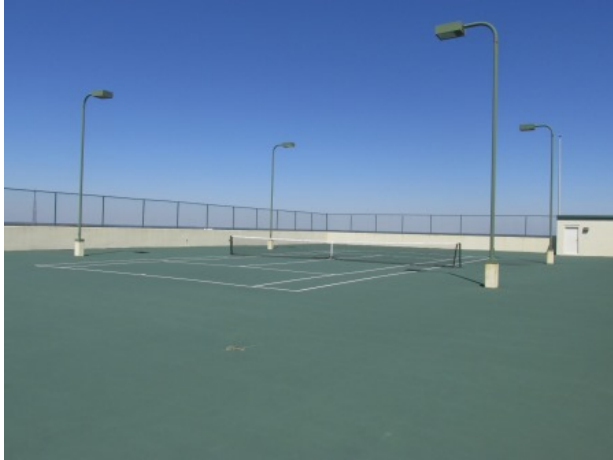
**Condition:** Good overall

**Tennis court overview**

**Component Detail Notes:** Prior to the application of the color coat, the Association should require the contractor to rout and fill all cracks with hot emulsion. This deters water infiltration and further deterioration of the asphalt playing surface.

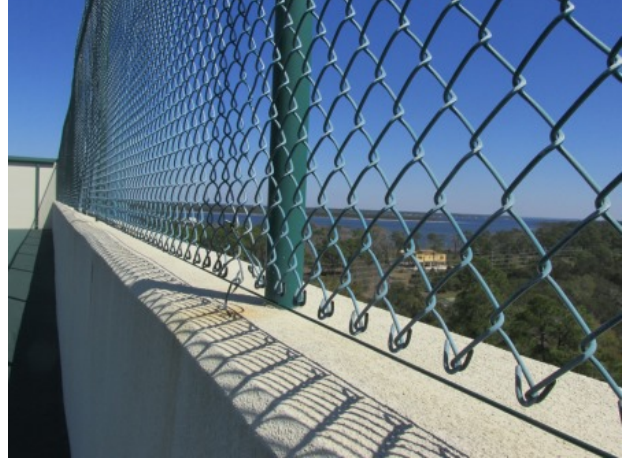
**Condition:** Good overall with fastener deterioration evident

**Fence webbing detached from post**

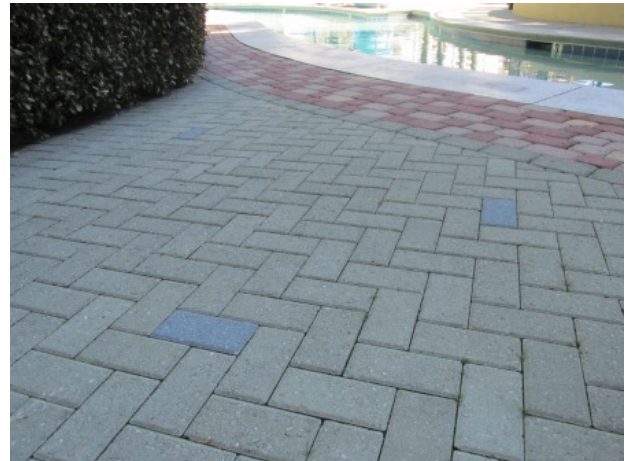
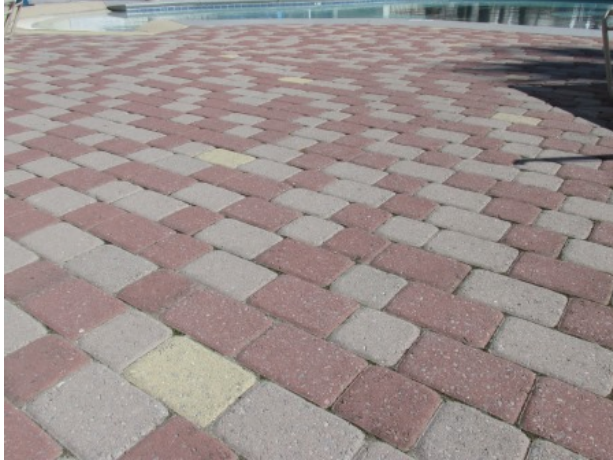
Masonry deck pavers

**Condition:** Good condition with isolated settlement evident

**Masonry deck pavers**

**Expenditure Detail Notes:** Expenditure timing and costs are depicted in the **Reserve Expenditures** table in Section 3. We recommend the Association conduct interim resetting and replacement of minor areas of pavers as normal maintenance, funded through the operating budget.

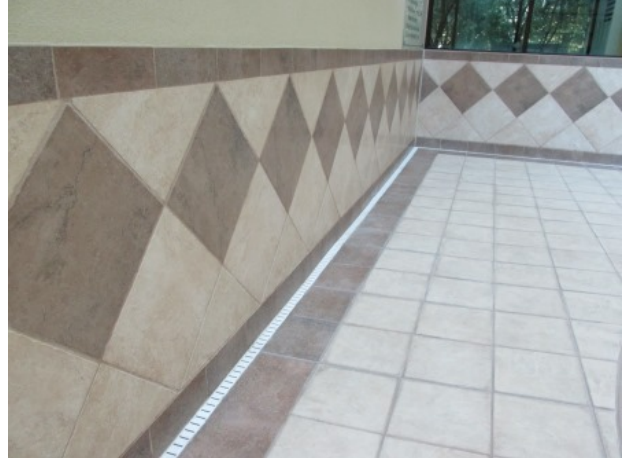
**Condition:** Good condition

**Indoor tile pool deck**

**Wall tile at indoor pool**

**Component Detail Notes:** We recommend the Association budget for replacement of the tile at the deck and walls every 25 years.

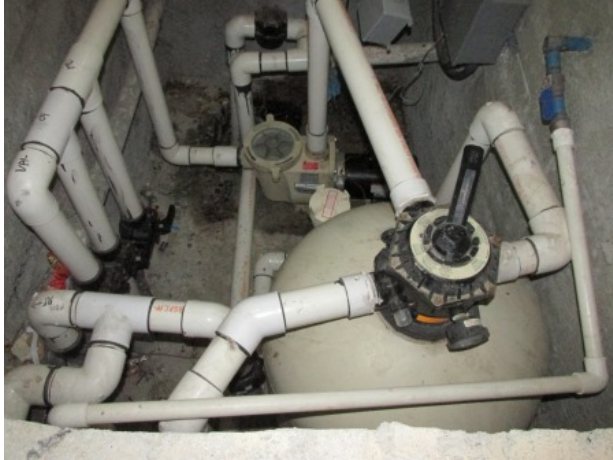
**Condition:** Reported satisfactory

**Pump and filter**

**Large lazy river pump**

**Sand filters**

**Expenditure Detail Notes:** Expenditure timing and costs are depicted in the **Reserve Expenditures** table in Section 3. Failure of the mechanical equipment as a single event is unlikely. We consider interim replacement of motors and minor repairs as normal maintenance. Our estimate of cost includes mechanical equipment for the indoor pool, two indoor spas, bird pool, kiddie pool and lazy river.

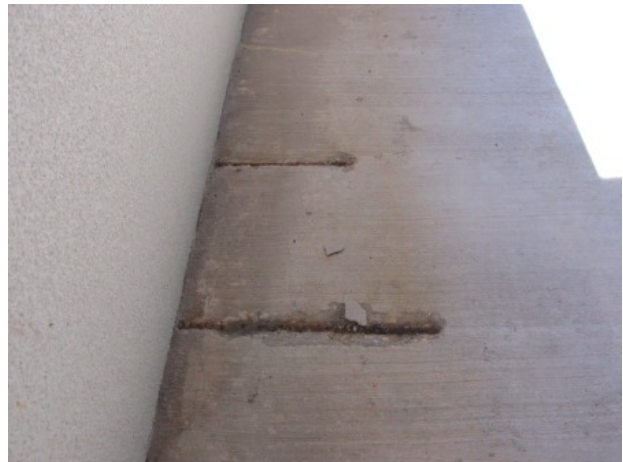
**Condition:** Good to fair overall with exposed reinforcing steel and isolated stalactites evident. The elevated structural concrete does not utilize a protective traffic coating.

Exposed reinforcement on driving surface

- Complete inspection of the garage concrete
- Partial depth concrete replacement of a limited amount of the surface area of the concrete floors
- Partial depth concrete replacement of a limited amount of the surface area of the elevated structural concrete ceilings
- Remediation of structural concrete columns and beams as needed
- Crack repairs on all surfaces as needed

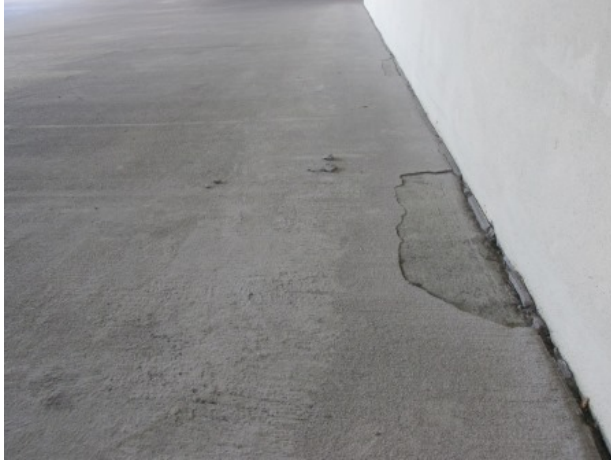
**Chipped concrete at the driving surface**

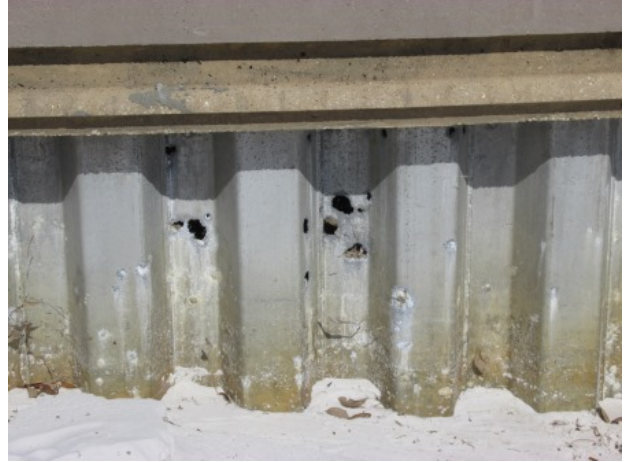
**Conditions:** The steel bulkheads are in fair condition with widespread holes evident. The vinyl bulkheads are in good overall condition.

**Holes in steel bulkhead**

**Expenditure Detail Notes:** Expenditure timing and costs are depicted in the **Reserve Expenditures** table in Section 3. We recommend the Association budget for complete

replacement of the steel bulkhead with a vinyl bulkhead. Upon replacement of the steel bulkhead, we estimate that up to 175 linear feet of vinyl bulkheads, or twenty percent (20%) of the total, will require replacement during the next 30 years.
