Phoenix On The Bay II Owners Association, Inc.

Orange Beach, AL • December 9, 2022

RESERVE STUDY

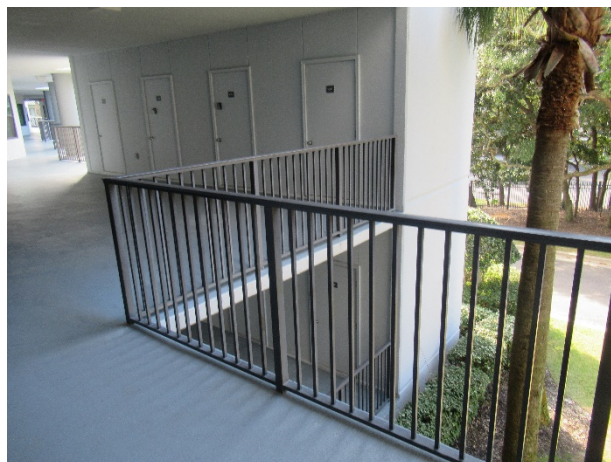
Condition: Good overall

Overview of railings

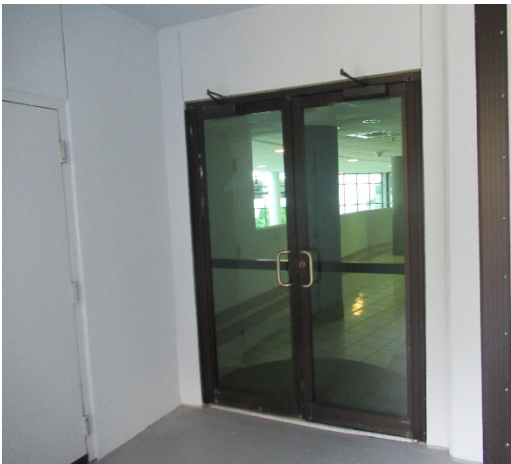
Condition: Good overall

Common area doors

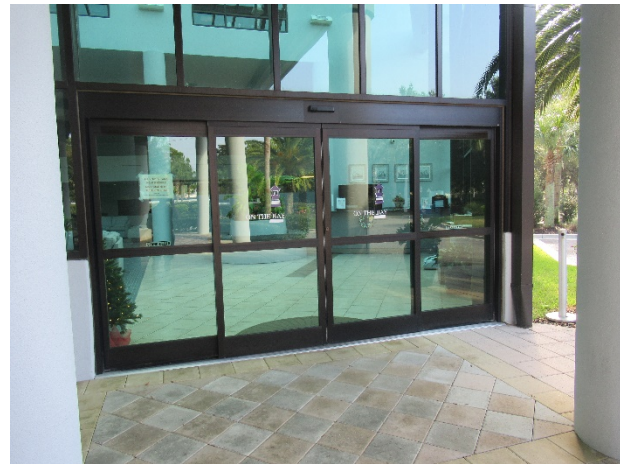
History: Management informs us the front entry doors were replaced in 2020. The common area doors are original

Lobby area entrance doors

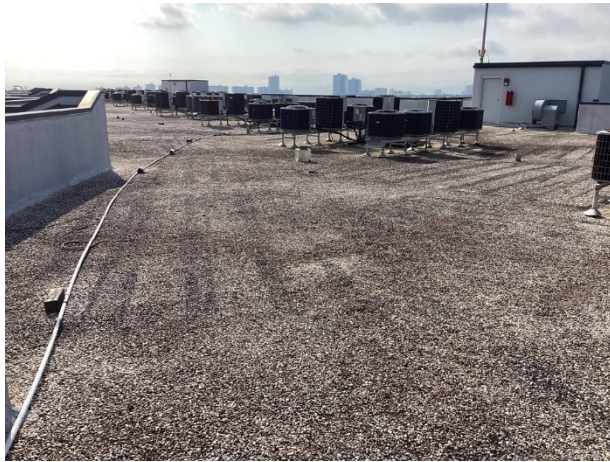
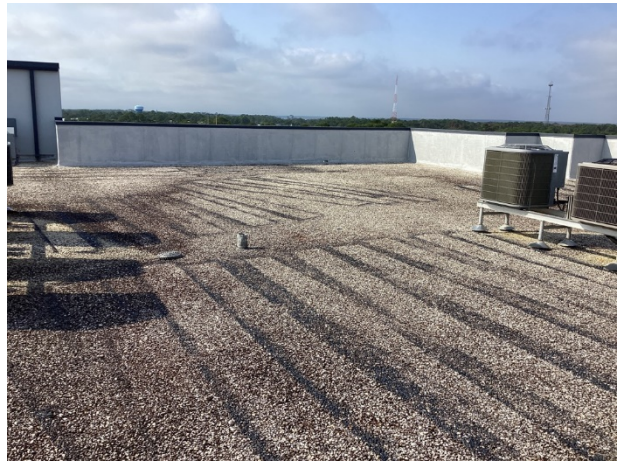
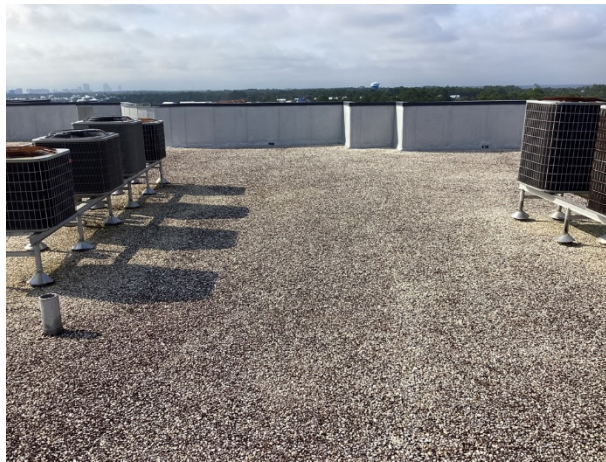
Condition: Good overall. Management and the Board do not report history of leaks.

Built-up roof overview

History: Original The Association conducts inspections of the roofs annual. We concur with this preventive maintenance practice and recommend the Association continue to fund these inspections through the operating budget.

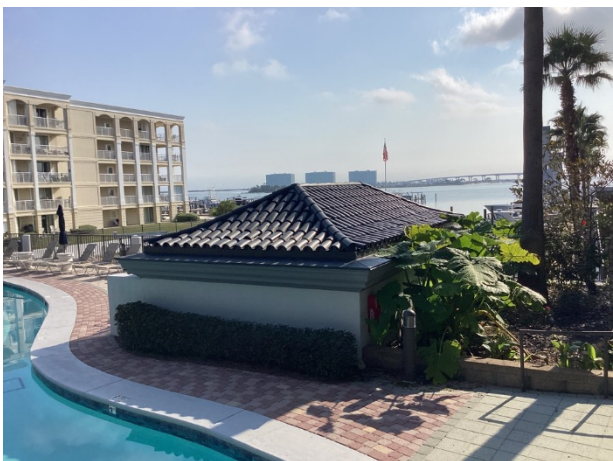
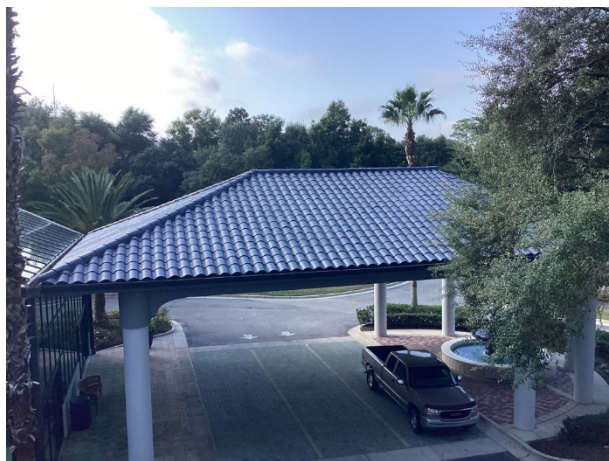
Condition: Good overall with no significant deterioration evident from our visual inspection from the ground. Management and the Board do not report a history of leaks.

Concrete tile roof

Concrete tile roofs overview

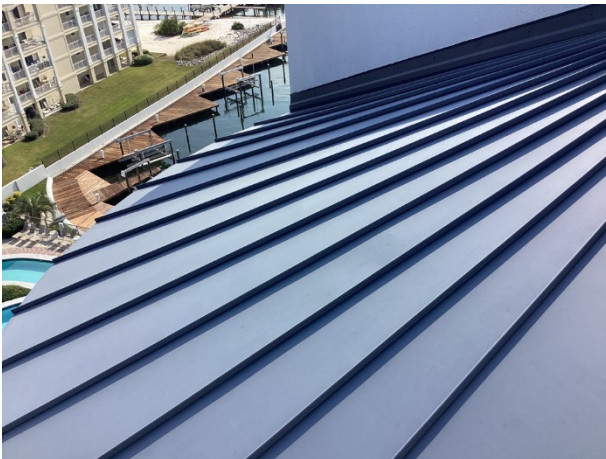
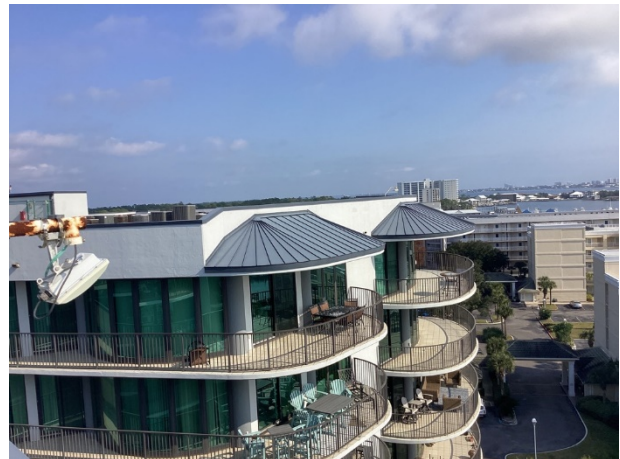
Condition: Good overall with no significant deterioration evident from our visual inspection from the ground. Management and the Board do not report a history of leaks.

Metal roofs overview

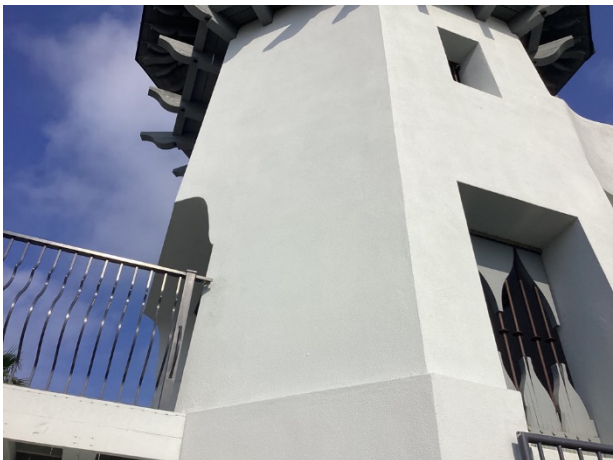
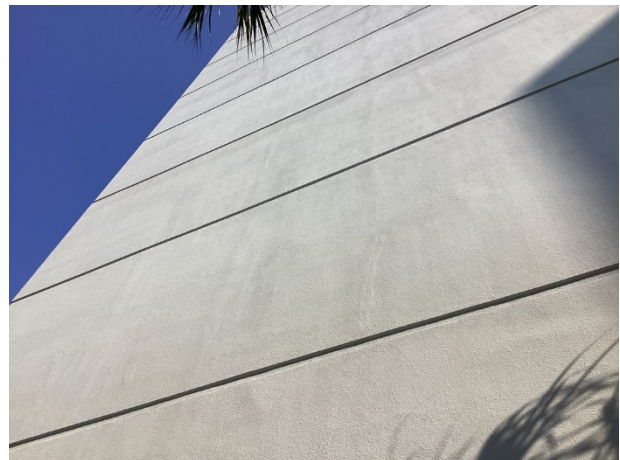
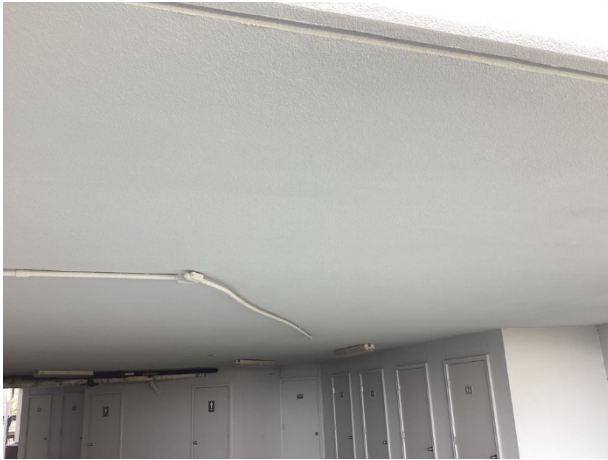
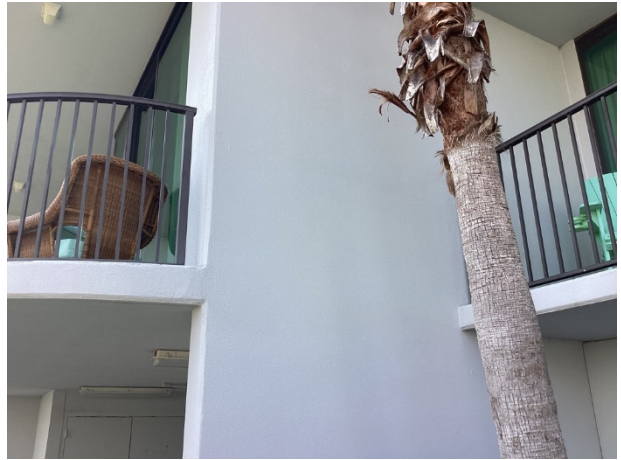
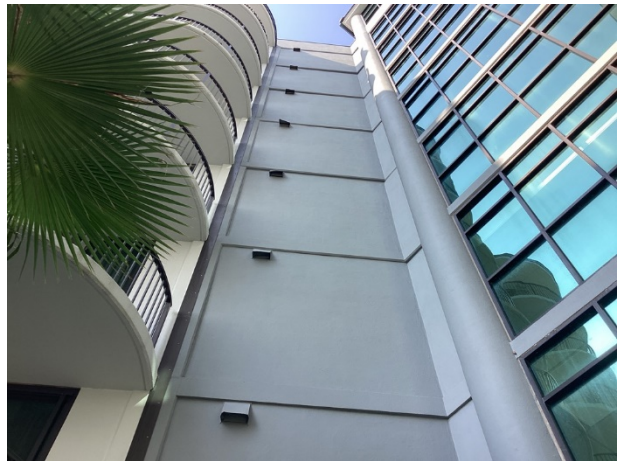
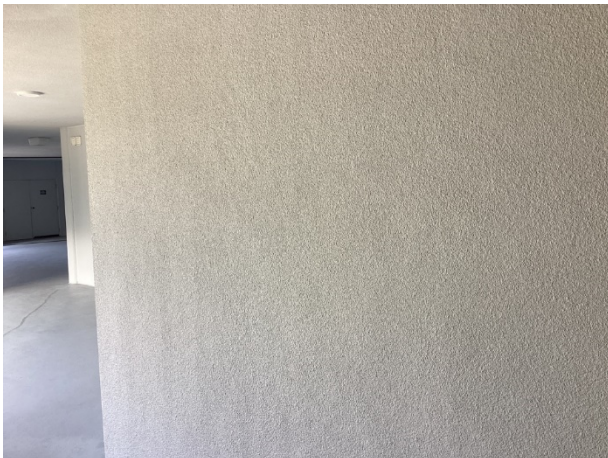
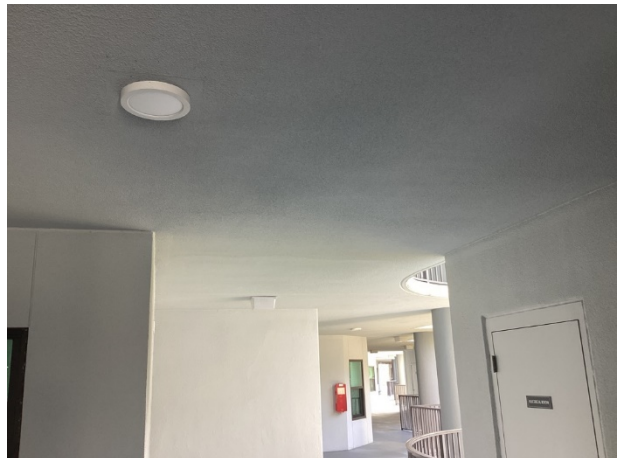
Condition: Good to fair overall with isolated cracks evident.

Stucco wall finishes

Useful Life: We recommend inspections, repairs and paint finish applications every five- to seven-years.

Correct and complete preparation of the surface before application of the paint finish maximizes the useful life of the paint finish and surface. The contractor should remove all loose, peeled or blistered paint before application of the new paint finish. The contractor should then power wash the surface to remove all dirt and biological growth. Water-soluble cleaners that will not attack Portland cement are acceptable for removing stains.

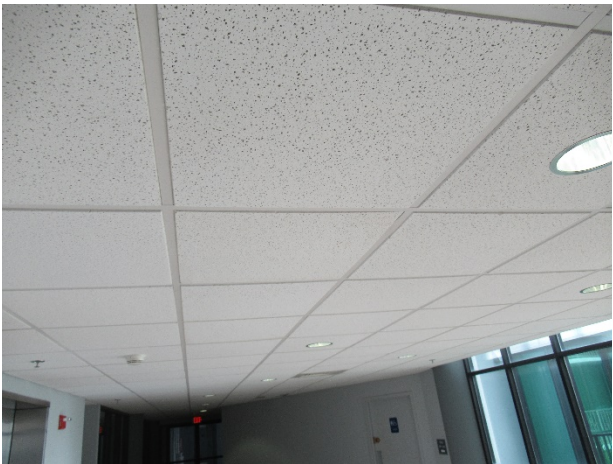
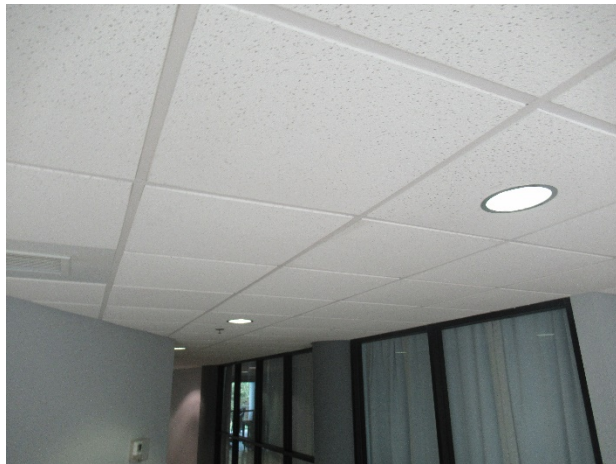
Condition: Good overall

Overview of acoustic ceiling tiles

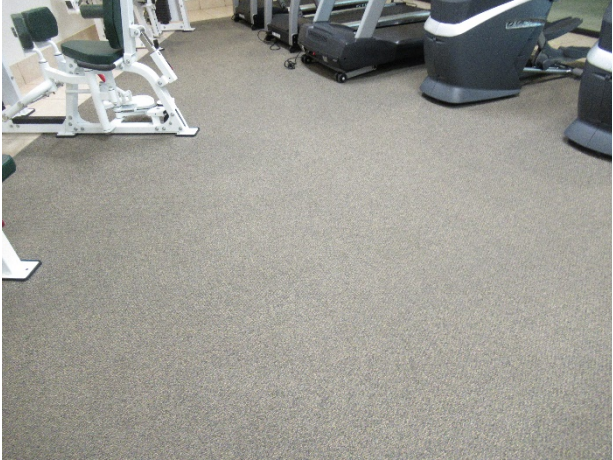
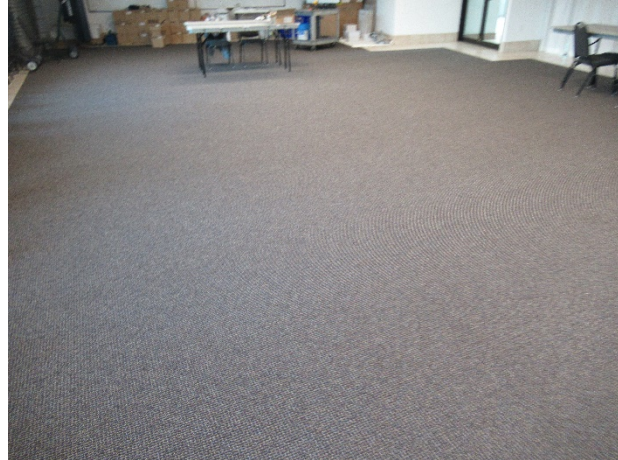
Condition: Good overall

Overview of carpet floor coverings

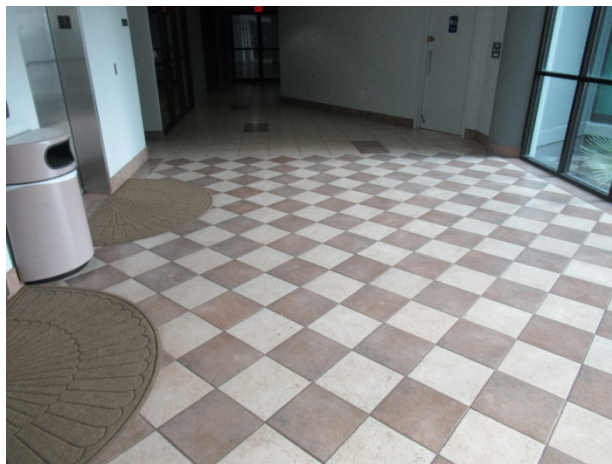
Condition: Good overall

Overview of tile floor coverings

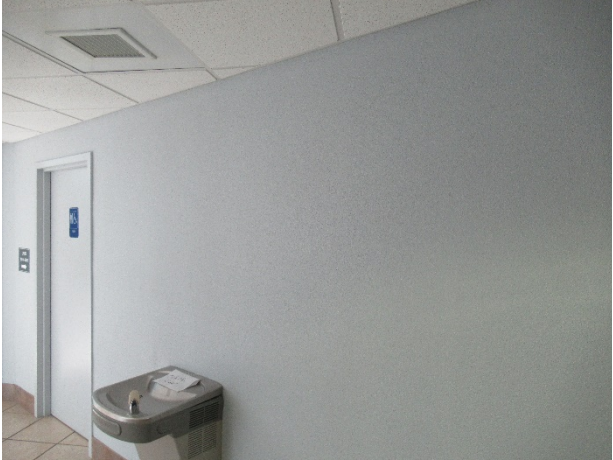
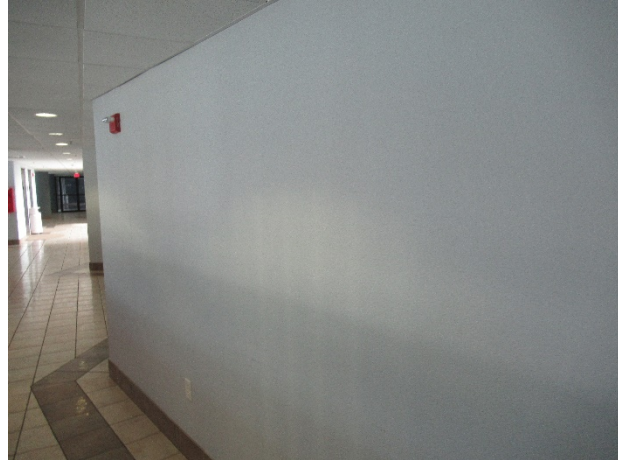
Condition: Good overall

Overview of interior paint finishes

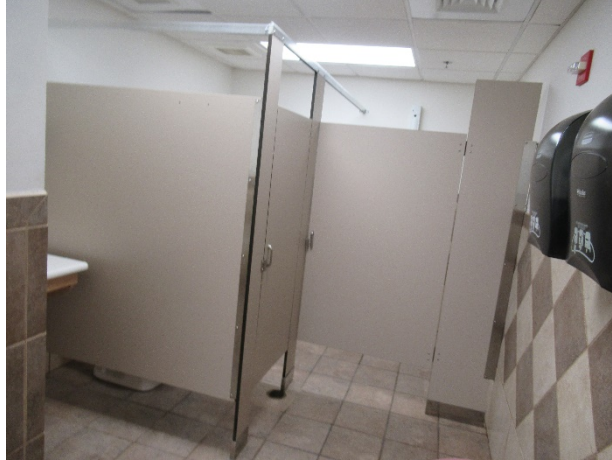
Condition: Good to fair overall

Overview of restroom

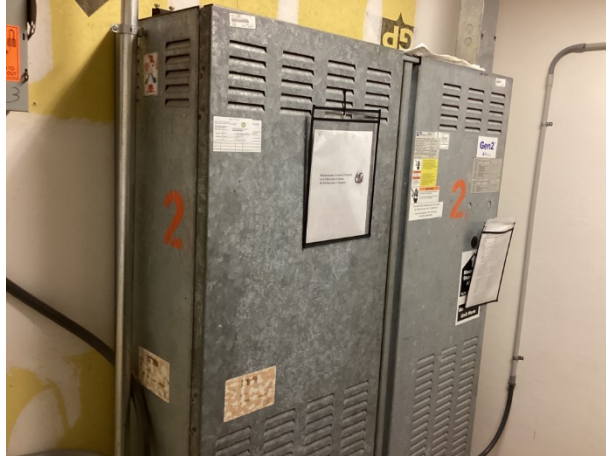
Condition: Reported satisfactory and service interruptions are reportedly infrequent.

Traction elevator controls

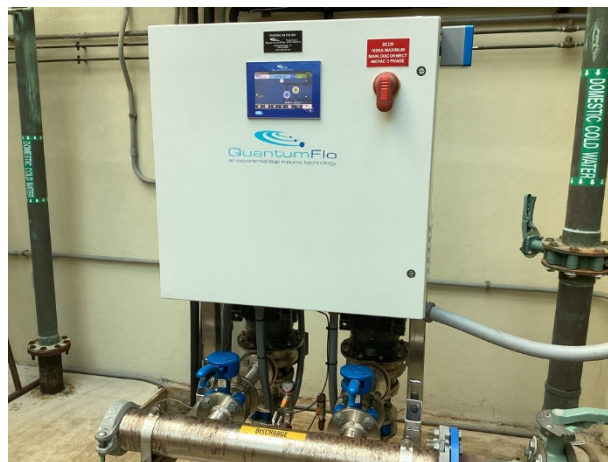
Condition: Reported satisfactory without operational deficiencies.

Domestic water pumps

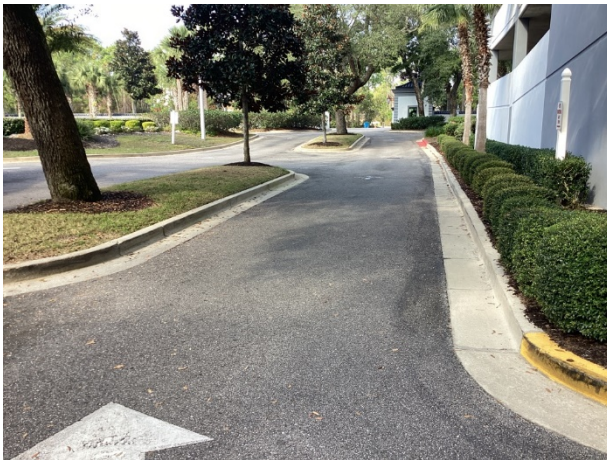
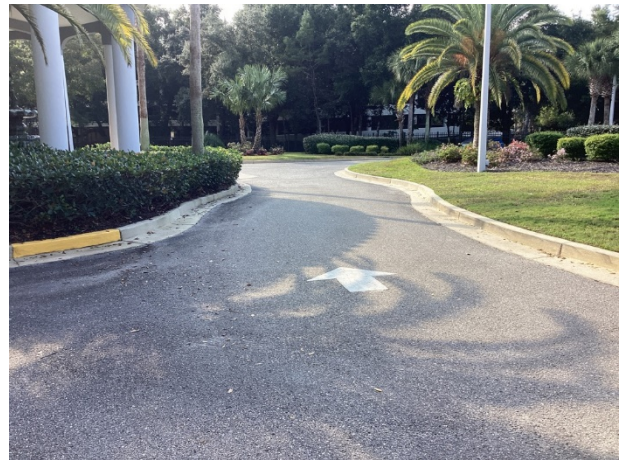
Condition: Good to fair overall with isolated cracks and settlement evident. We note centerline deterioration at the pavement due to the drainage system.

Asphalt pavement street overview

The manner of repaving is either a mill and overlay or total replacement. A mill and overlay is a method of repaving where cracked, worn and failed pavement is mechanically removed or milled until sound pavement is found. A new layer of asphalt is overlaid atop the remaining base course of pavement. Total replacement includes the removal of all existing asphalt down to the base course of aggregate and native soil followed by the application of two or more new lifts of asphalt. We recommend mill and overlayment on asphalt pavement that exhibits normal deterioration and wear. We recommend total replacement of asphalt pavement that exhibits severe deterioration, inadequate drainage, pavement that has been overlaid multiple times in the past or where the configuration makes overlayment not possible. Based on the apparent visual condition and configuration of the asphalt pavement, we recommend the mill and overlay method of repaving at Phoenix On The Bay II.

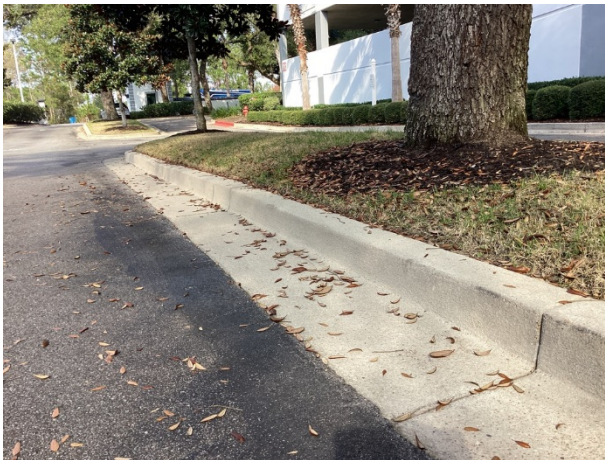
Condition: Good to fair overall with isolated cracks evident.

Concrete curb and gutter

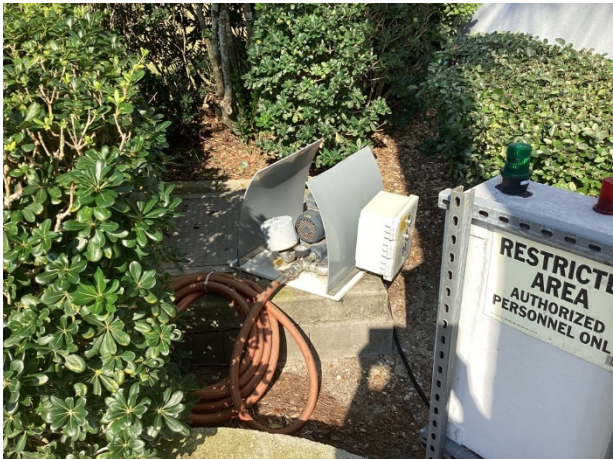
Condition: Reported satisfactory without operational deficiencies

Lift station pump

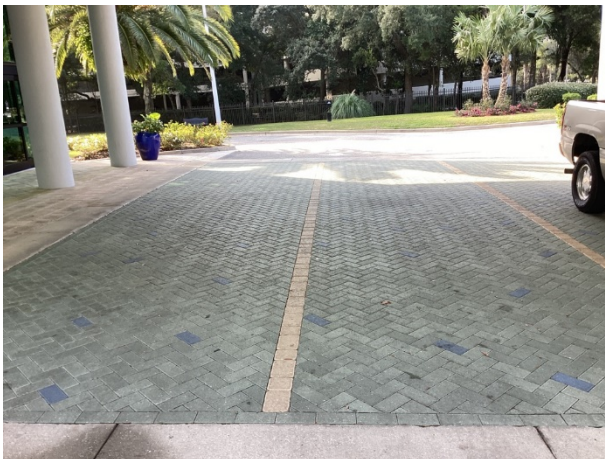
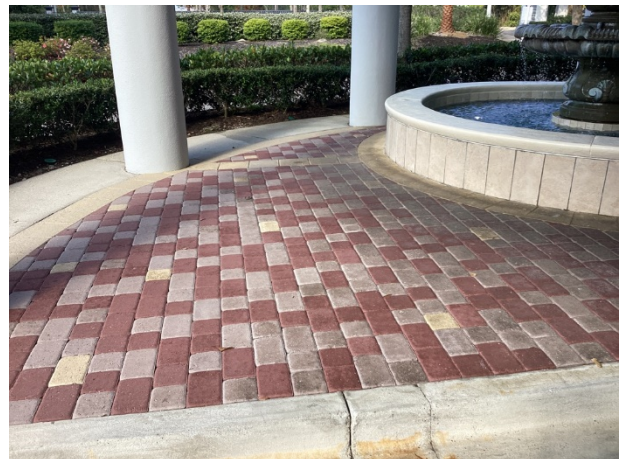
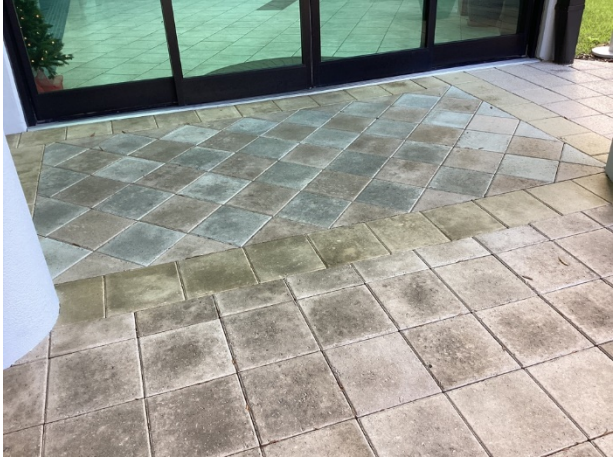
Condition: Good to fair overall

Masonry pavers overview

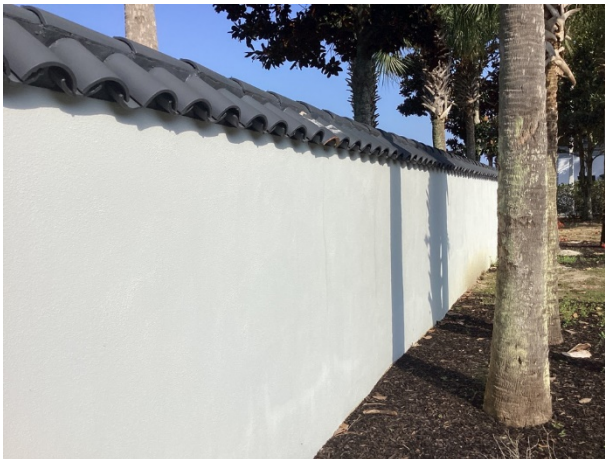
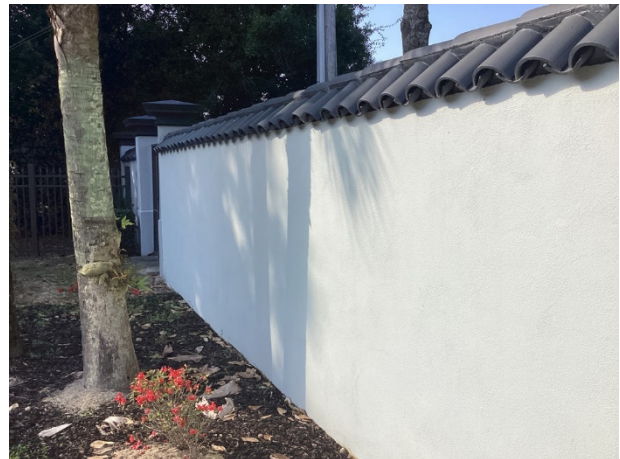
Condition: The walls are in good to fair condition overall and paint finish is in good to fair condition overall with isolated cracks evident.

Stucco perimeter wall overview

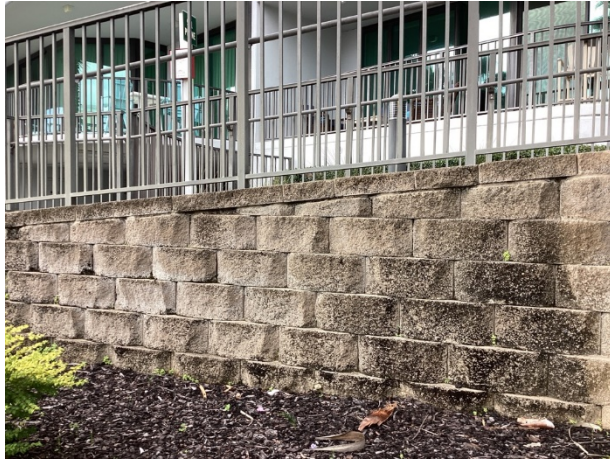
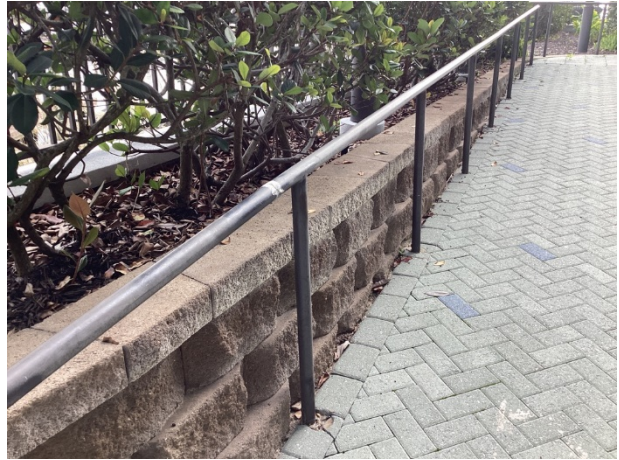
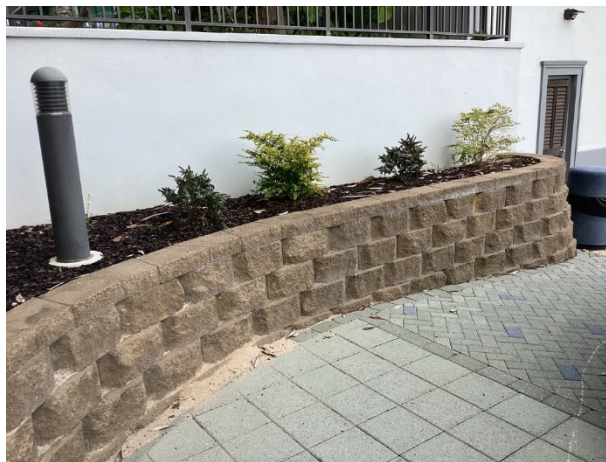
Condition: Good overall

Masonry retaining wall

Masonry retaining walls overview

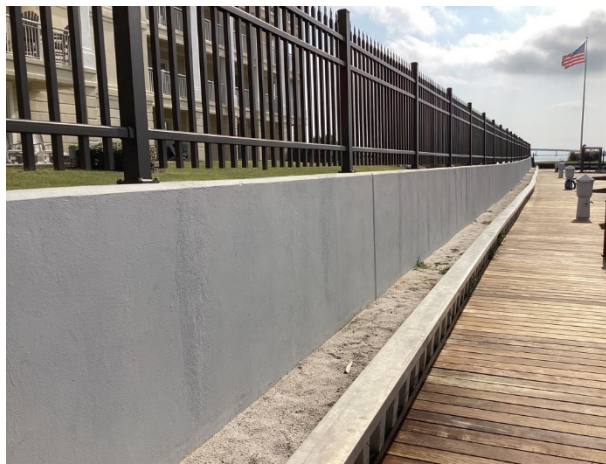
Condition: Good overall

Concrete retaining walls overview

Useful Life: Concrete retaining walls have indeterminate useful lives. However, we recommend the Association plan for inspections and capital repairs every five- to seven-years to forestall deterioration.

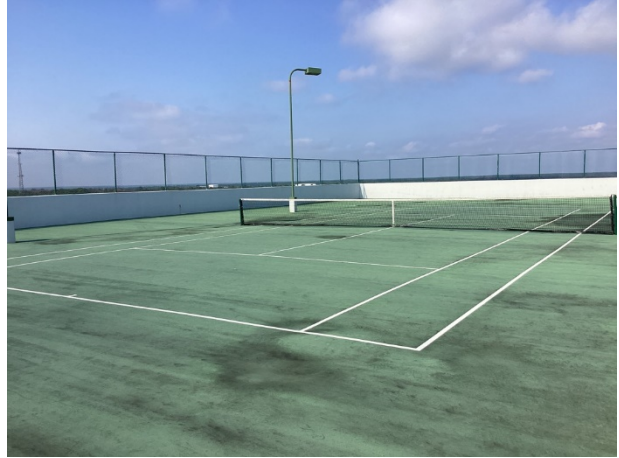
Tennis court overview

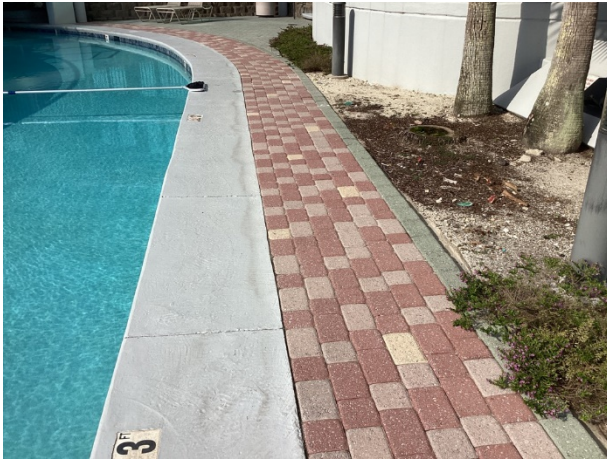
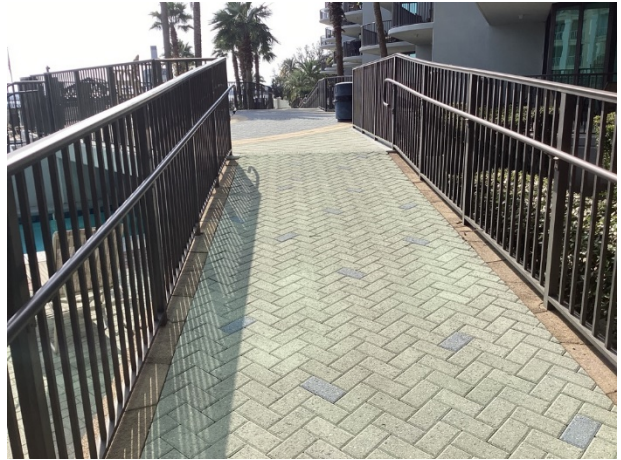
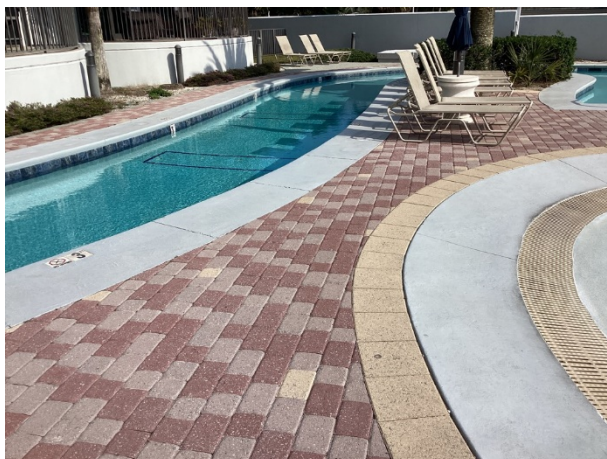
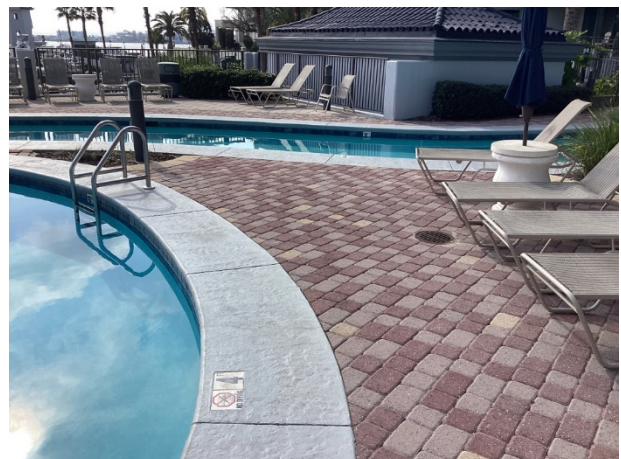
Condition: Good overall

Paver pool deck overview

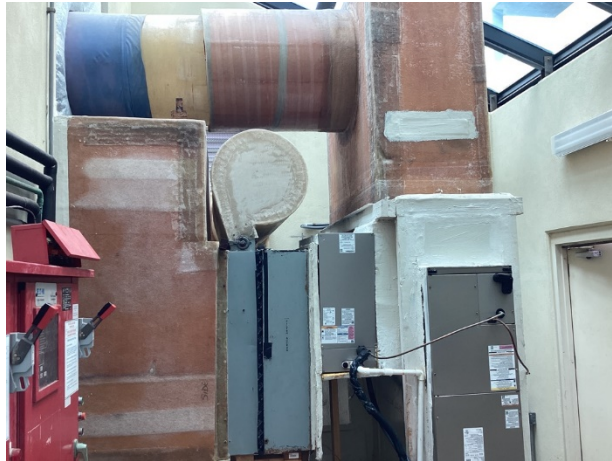
Condition: Reported satisfactory

Pool dehumidification unit

Preventative Maintenance Notes: We recommend the Association obtain and adhere to the manufacturer's recommended maintenance plan. We also recommend the Association maintain a maintenance contract with a qualified professional. The required preventative maintenance may vary in frequency and scope based on the unit's age, operational condition, or changes in technology. We note the following select recommended preventative maintenance activities to maximize the remaining useful life:

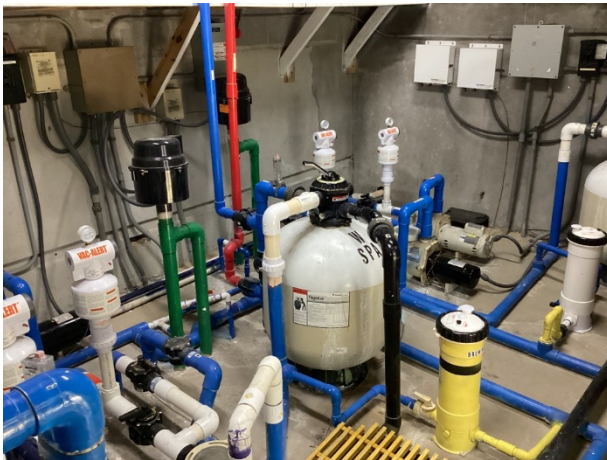
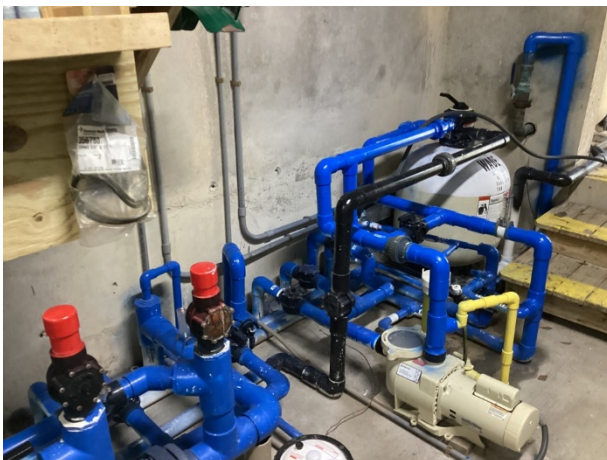
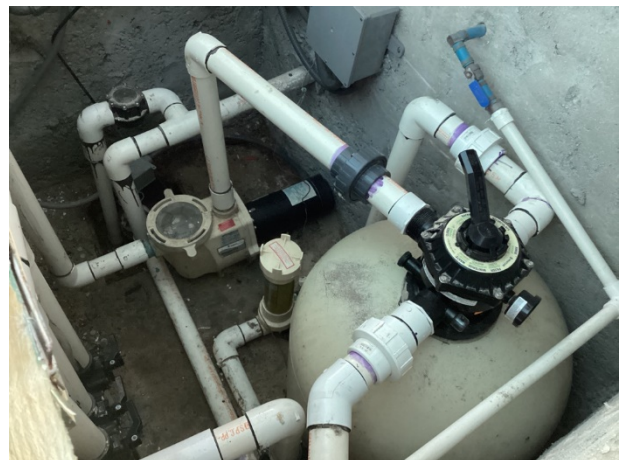
Condition: Reported satisfactory without operational deficiencies

Pool mechanical equipment

Pool filters

Pool mechanical equipment for fountains

Lazy river pump

Expenditure Detail Notes: Expenditure timing and costs are depicted in the **Reserve Expenditures** table in Section 3. Failure of the pool mechanical equipment as a single event is unlikely. Therefore, we include replacement of up to fifty percent (50%) of the equipment per event. We consider interim replacement of motors and minor repairs as normal maintenance.

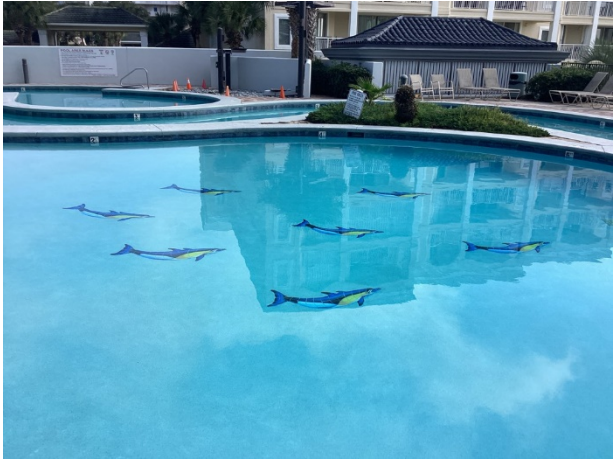
Condition: Good

Pool plaster overview

Lazy river plaster overview

Dolphin pool plaster overview

Overview of indoor pool

Overview of indoor spa

Expenditure Detail Notes: Expenditure timing and costs are depicted in the **Reserve Expenditures** table in Section 3. We recommend the Association budget for full tile replacement every other plaster replacement event. Removal and replacement of the finish provides the opportunity to inspect the pool structures and to allow for partial repairs of the underlying concrete surfaces as needed. To maintain the integrity of the pool structures, we recommend the Association budget for the following:

- Removal and replacement of the plaster finishes
- Partial replacements of the scuppers and coping as needed
- Replacement of tiles as needed
- Replacement of joint sealants as needed
- Concrete structure repairs as needed

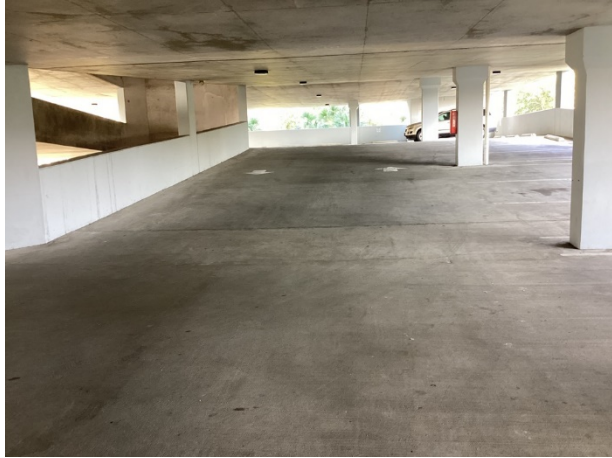
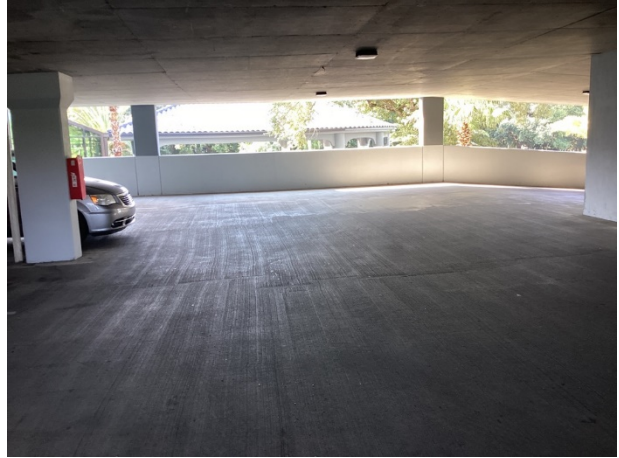
Condition: Good to fair overall with isolated cracks and exposed reinforcing steel evident. The elevated structural concrete does not utilize a protective traffic coating

Elevated garage floor overview

- Complete inspection of the garage concrete
- Partial depth concrete replacement of a limited amount of the surface area of the concrete floors
- Partial depth concrete replacement of a limited amount of the surface area of the elevated structural concrete ceilings
- Remediation of structural concrete columns and beams as needed
- Crack repairs on all surfaces as needed

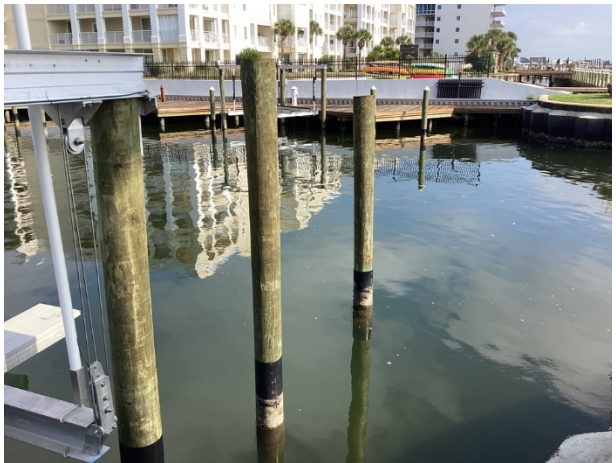
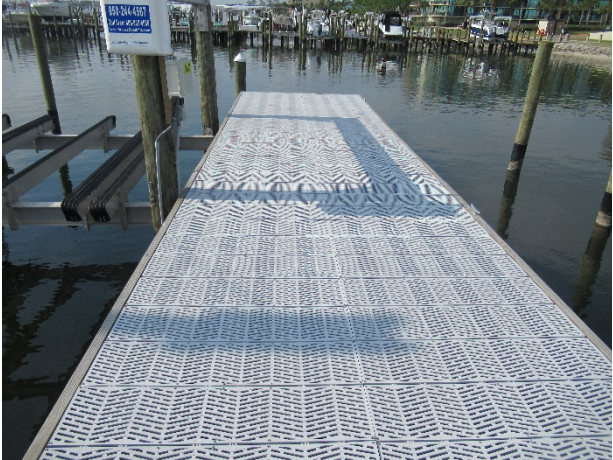
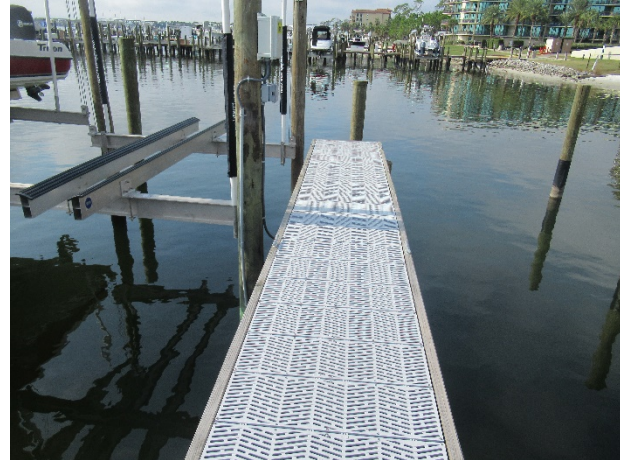
Condition: Good overall

Harbor deck boards

Harbor docks

Overview of wood pilings

Dock with composite decking

Expenditure Detail Notes: Expenditure timing and costs are depicted in the **Reserve Expenditures** table in Section 3. Our cost is based on information provided by the Association. Our cost for repairs includes allowances for complete replacement of the decking and partial replacement of up to ten percent (10%) of the structure and pilings. Our estimate of cost includes an allowance for removal and disposal of the existing docks, and installation of new docks and utility lines. Phoenix On The Bay II should fund interim replacements of utilities prior to replacement of the docks and annual repairs to displaced pilings through the operating budget.
