# FULL RESERVE STUDY

## Phoenix On The Bay II Owners Association, Inc.

**Orange Beach, Alabama**

**March 15, 2017**

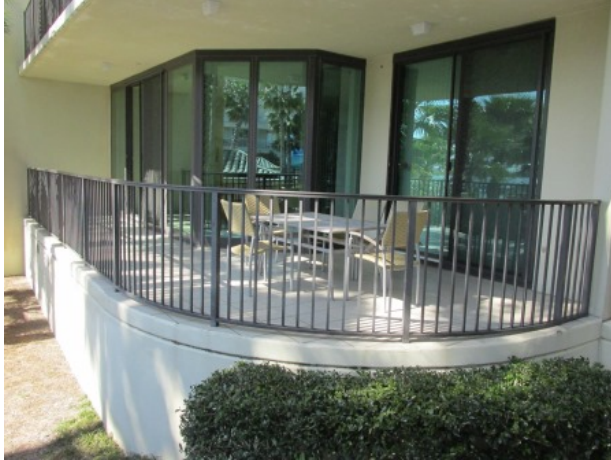
**Condition:** Good overall with finish deterioration, isolated cracks and exposed reinforcement evident.

**Lower balcony**

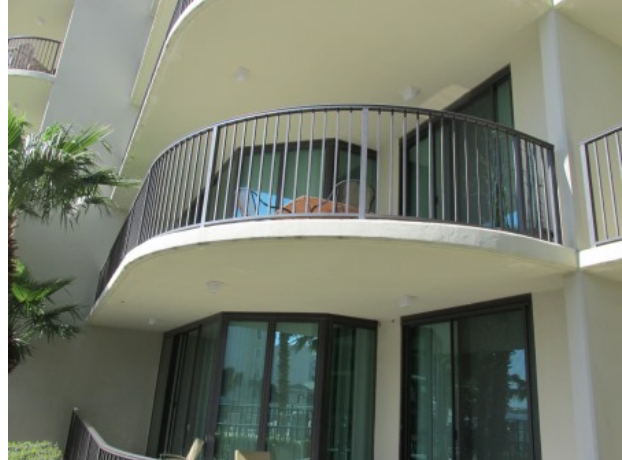
**Upper balcony**

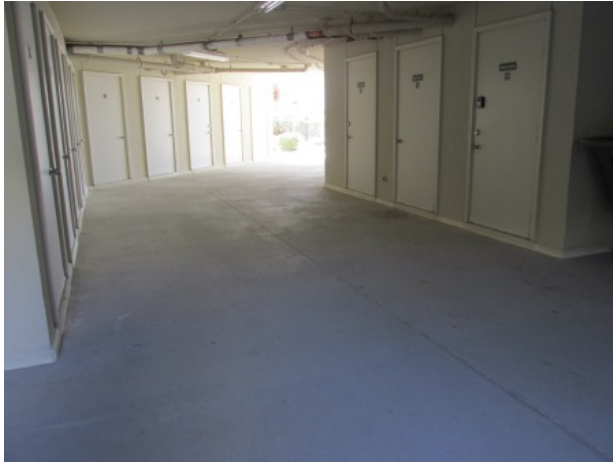
**Condition:** Good to fair overall with cracks and finish deterioration evident.

**Breezeway overview**

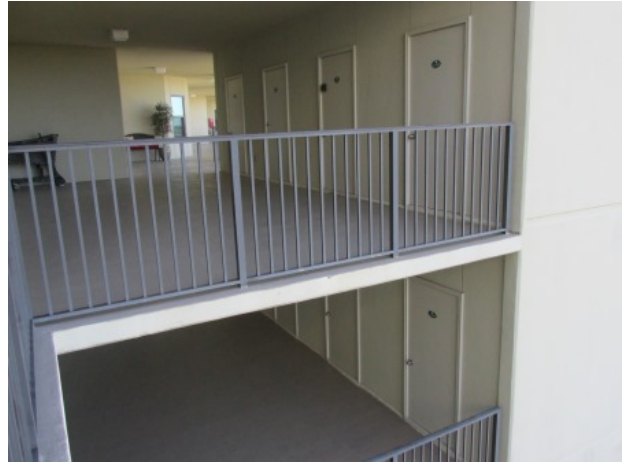
**Breezeway overview**

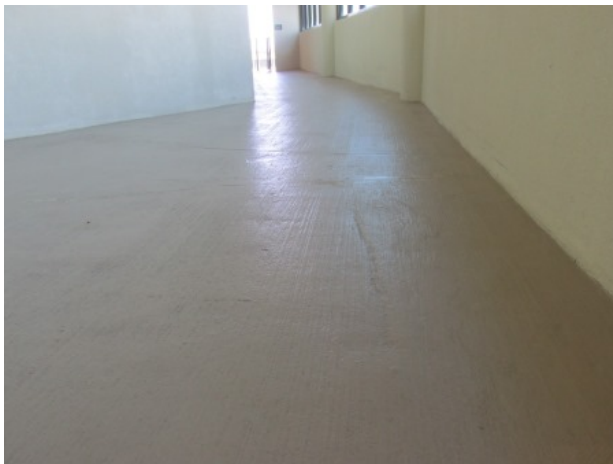
**Breezeway floor covering**

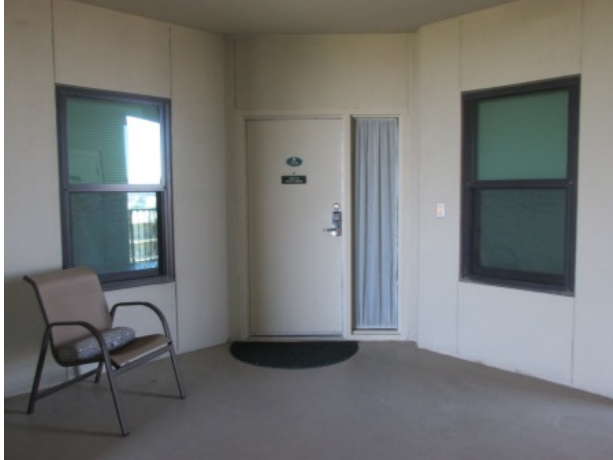
**Condition:** Good overall with isolated rust evident.

**Front entry door**

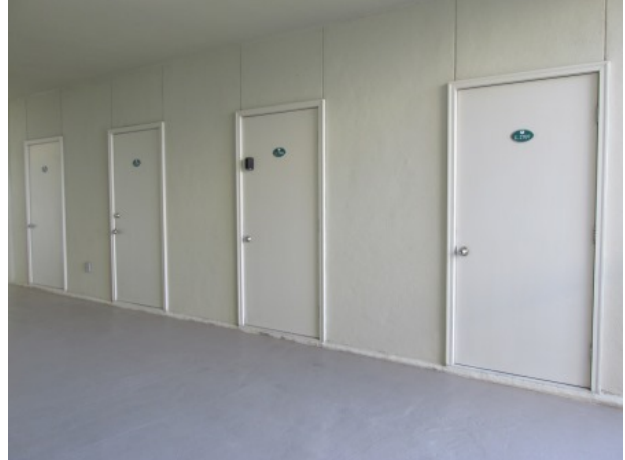
**Common doors**

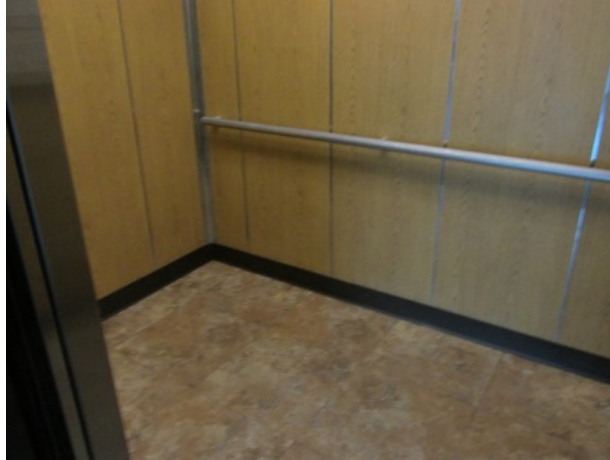
**Condition:** Fair overall

**Elevator cab finishes**

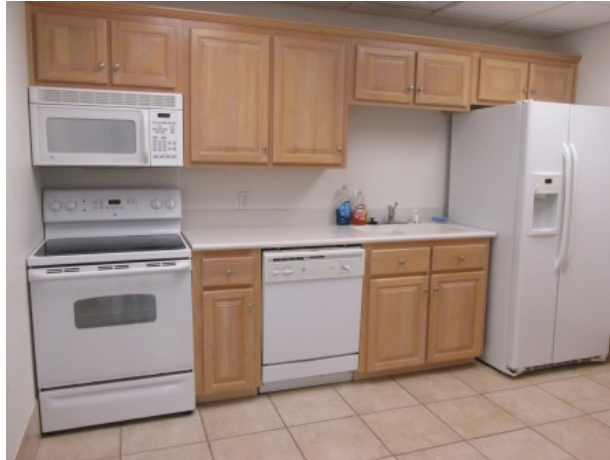
**Condition:** Good to fair overall

**Kitchen equipment**

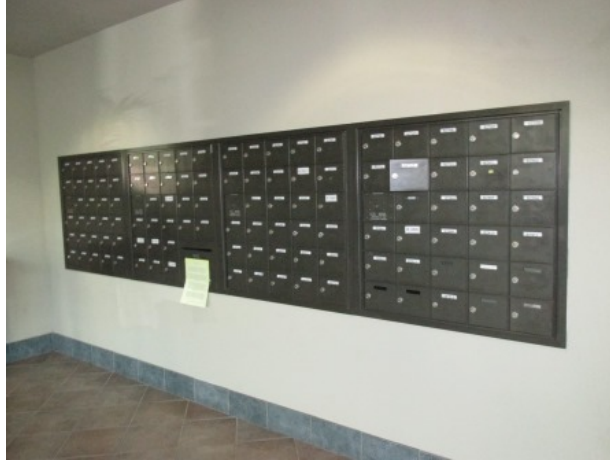
**Condition:** Good overall

**Mailboxes**

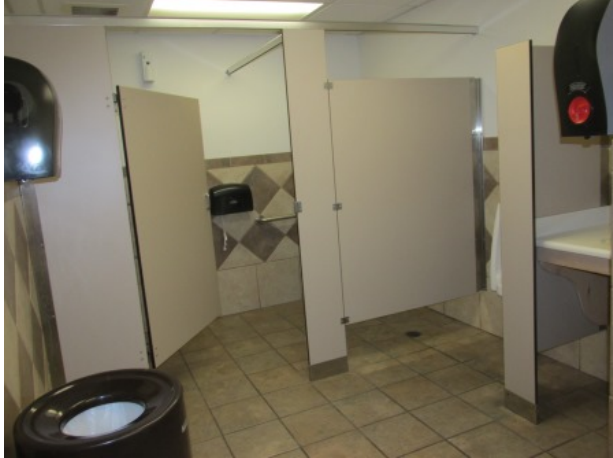
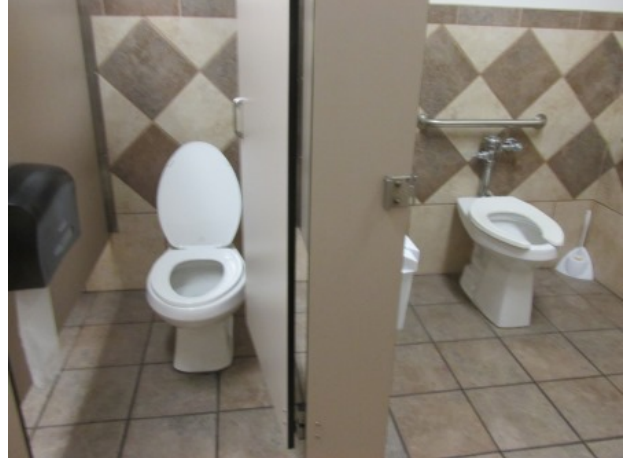
Typical rest room

**Condition:** Good to fair overall

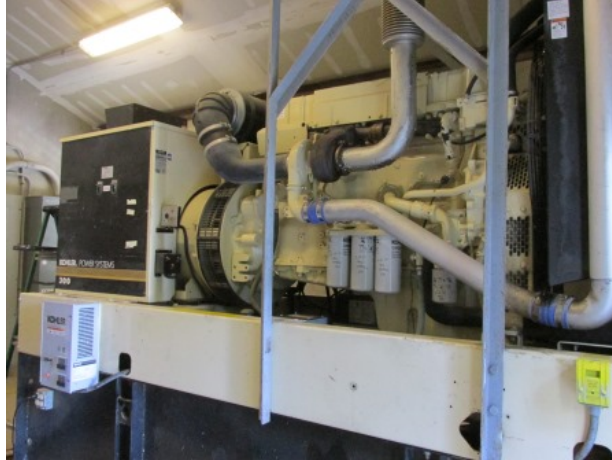
**Condition:** Reported satisfactory

**Emergency generator**

**Expenditure Detail Notes:** Expenditure timing and costs are depicted in the **Reserve Expenditures** table in Section 3. Our estimate of cost includes replacement of the transfer switch.

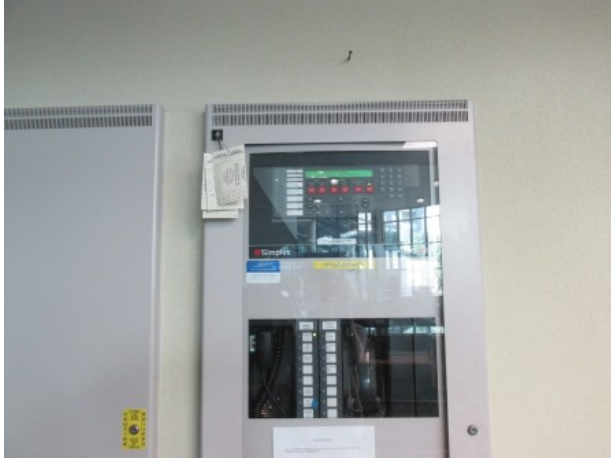
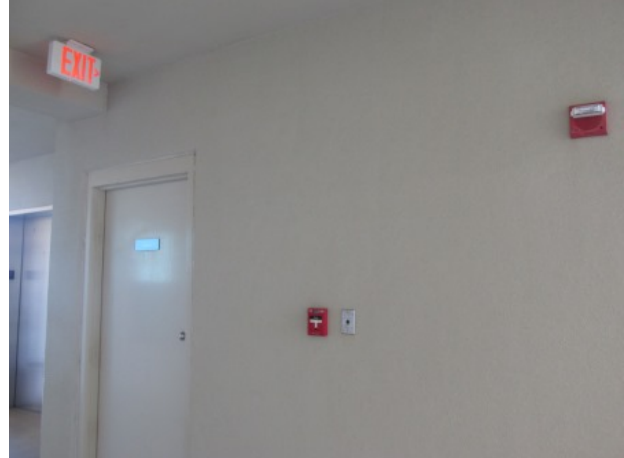
**Conditions:** Reported satisfactory

**Control panel**

**Emergency devices**

**Expenditure Detail Notes:** Expenditure timing and costs are depicted in the **Reserve Expenditures** table in Section 3. Changes in technology or building codes may make a replacement desirable prior to the end of the functional life. Our estimate of future cost considers only that amount necessary to duplicate the same functionality. Local codes or ordinances at the actual time of replacement may require a betterment as compared to the existing system. A betterment could result in a higher, but at this time unknown, cost of replacement. We recommend the Association fund interim control panel replacements through the operating budget.

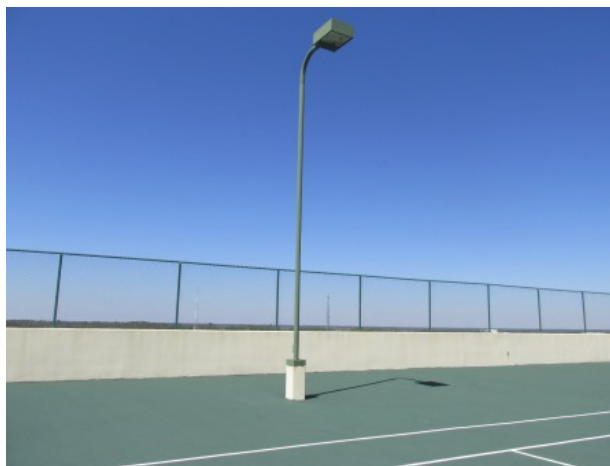
**Condition:** Good overall

**Tennis court light pole**

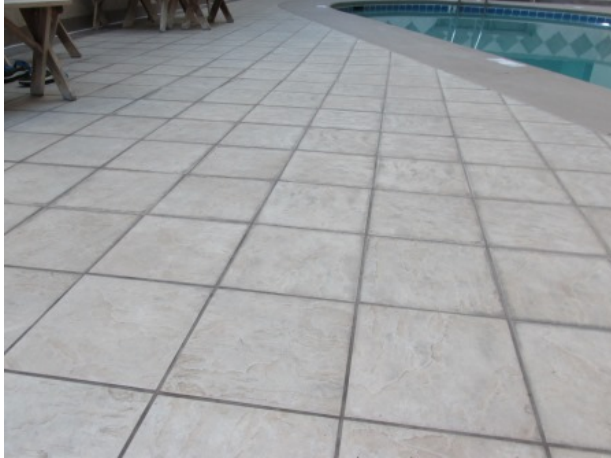
**Condition:** Good condition

**Indoor tile pool deck**

**Wall tile at indoor pool**

**Component Detail Notes:** We recommend the Association budget for replacement of the tile at the deck and walls every 25 years.

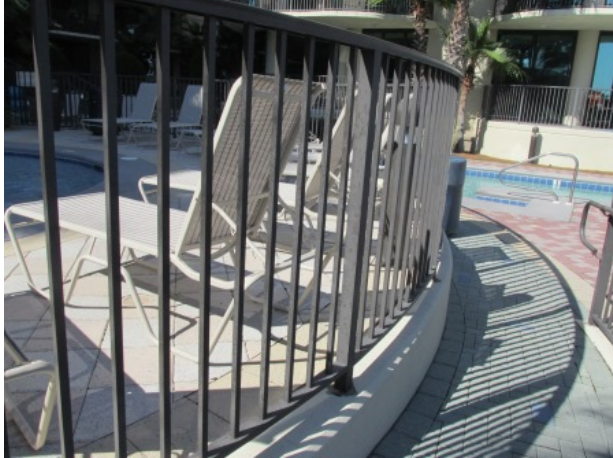
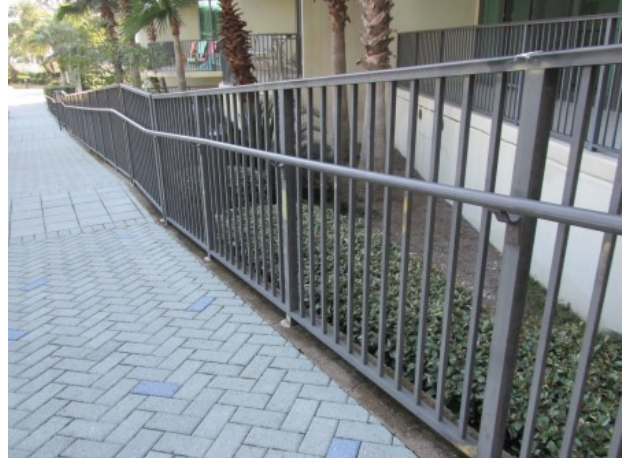
**Pool fence**

**Condition:** Good overall condition

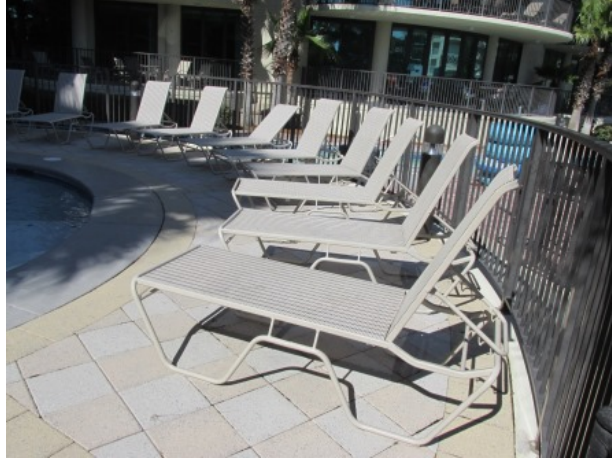
**Condition:** Good overall

**Pool furniture**

**Expenditure Detail Notes:** Expenditure timing and costs are depicted in the **Reserve Expenditures** table in Section 3. We recommend interim re-strapping, refinishing, cushion replacements, reupholstering and other repairs to the furniture as normal maintenance to maximize its useful life. We base our estimate of cost on information provided by Management and the Board.

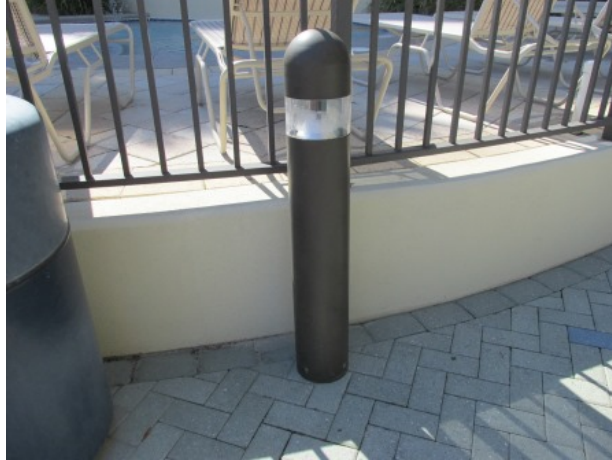
**Condition:** Good to fair overall

**Typical bollard light fixture**

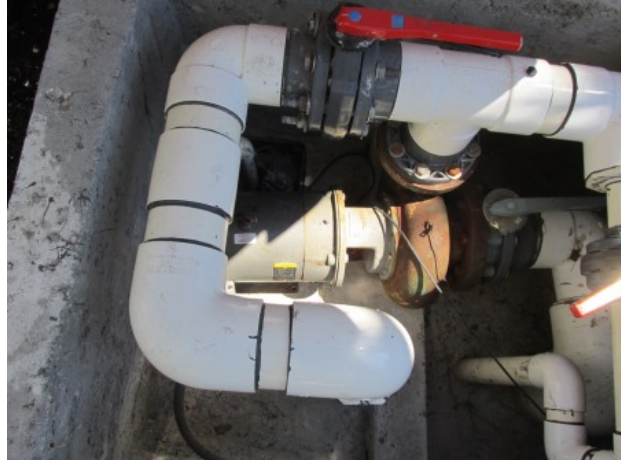
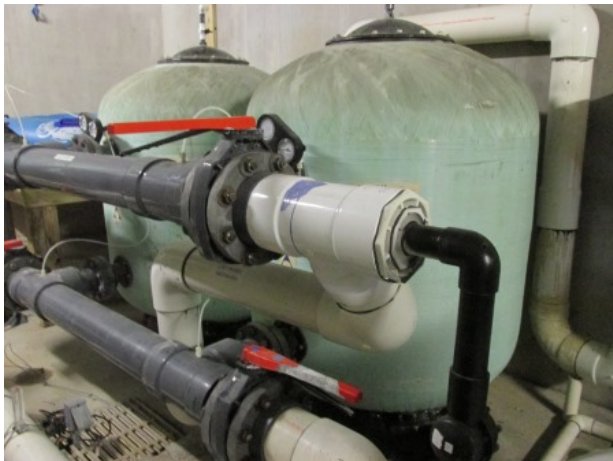
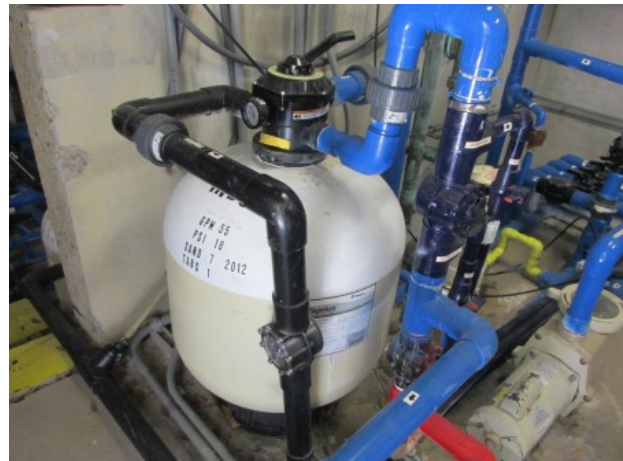
**Condition:** Reported satisfactory

**Pump and filter**

**Large lazy river pump**

**Sand filters**

**Expenditure Detail Notes:** Expenditure timing and costs are depicted in the **Reserve Expenditures** table in Section 3. Failure of the mechanical equipment as a single event is unlikely. We consider interim replacement of motors and minor repairs as normal maintenance. Our estimate of cost includes mechanical equipment for the indoor pool, two indoor spas, bird pool, kiddie pool and lazy river.

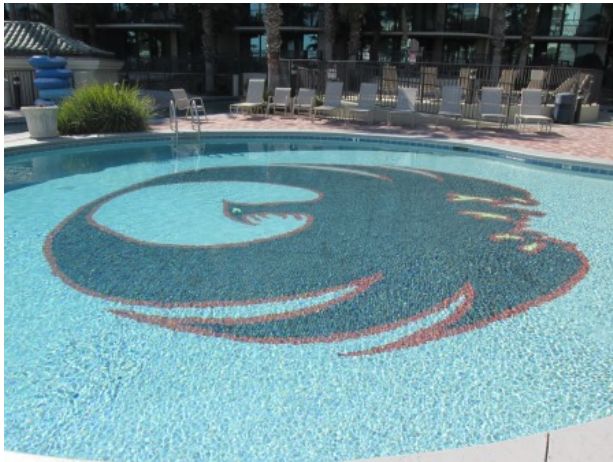
- Bird pool and lazy river – Fair overall. We note cracks throughout the lazy river
- Outdoor kiddie pool and indoor spas – Good overall
- Indoor pool – Good to fair overall with isolated discoloration

**Bird pool plaster finish**

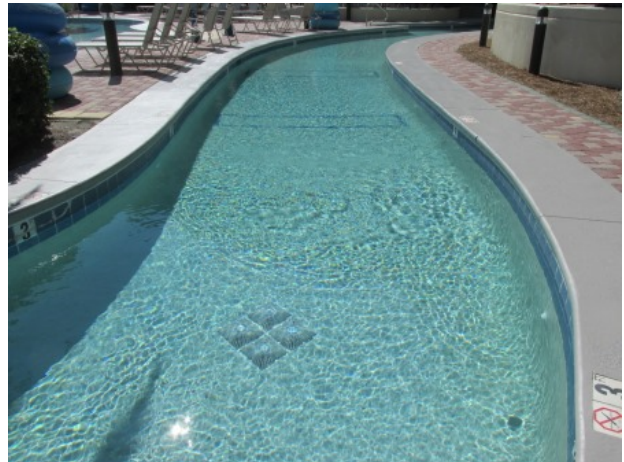
**Lazy river**

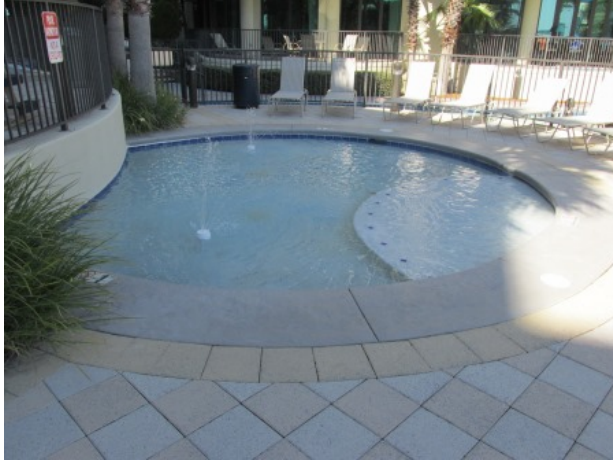
**Kiddie pool**

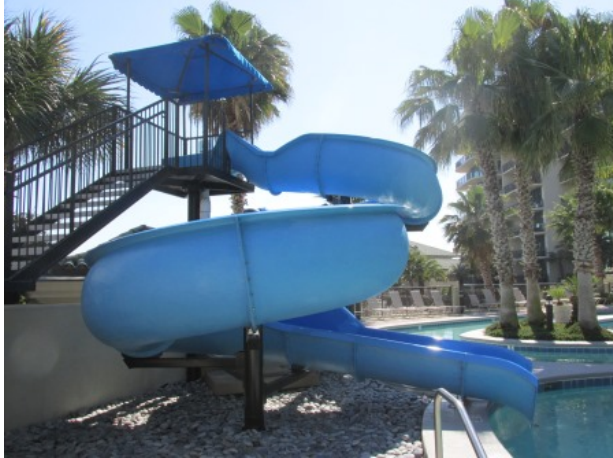
**Conditions:** Good overall

**Pool slide**

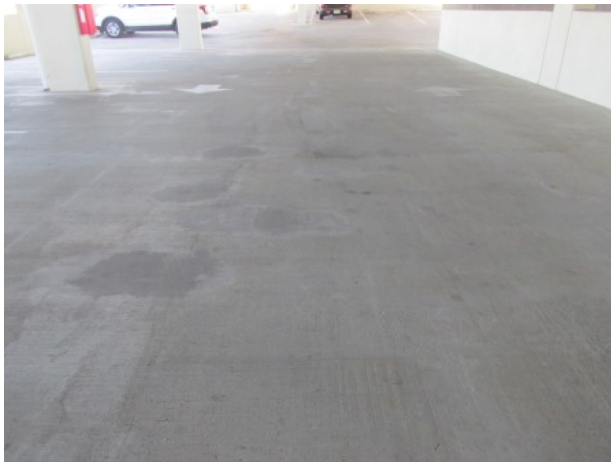
Garage overview

**Condition:** Good to fair overall with exposed reinforcing steel and isolated stalactites evident. The elevated structural concrete does not utilize a protective traffic coating.

- Complete inspection of the garage concrete
- Partial depth concrete replacement of a limited amount of the surface area of the concrete floors
- Partial depth concrete replacement of a limited amount of the surface area of the elevated structural concrete ceilings
- Remediation of structural concrete columns and beams as needed
- Crack repairs on all surfaces as needed

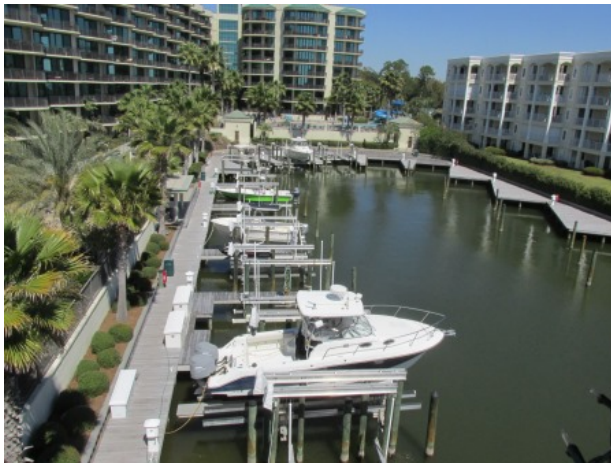
**Condition:** Good condition minor weathered boards

**Harbor docks**

**Expenditure Detail Notes:** Expenditure timing and costs are depicted in the **Reserve Expenditures** table in Section 3. We recommend the Association budget for replacement of the deck boards and up to ten percent (10%) of the pilings interim to complete replacement. Our estimate of cost includes an allowance for removal and disposal of the existing docks, and installation of new docks and utility lines.
