Phoenix On The Bay II Owners Association, Inc.

Orange Beach, AL • December 9, 2022

RESERVE STUDY

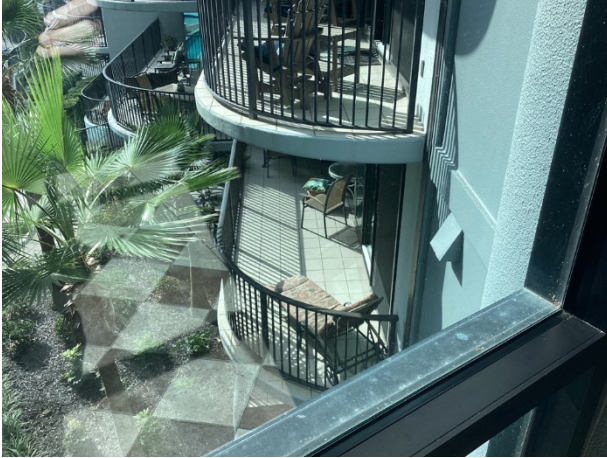
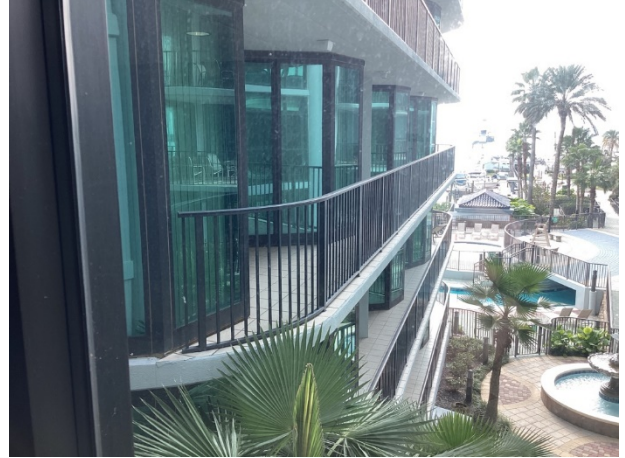
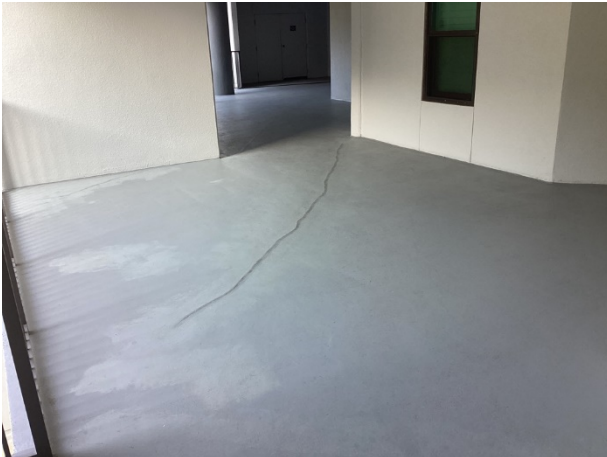
Condition: The balconies are in good overall condition and the breezeways are in good to fair overall condition with isolated cracks and chipped coatings evident

Balcony overview

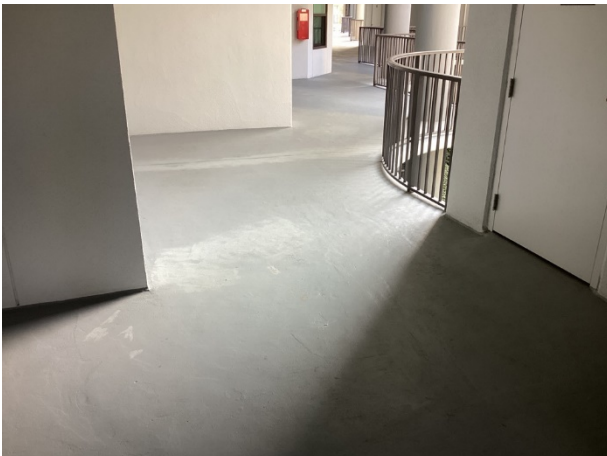
Breezeway overview

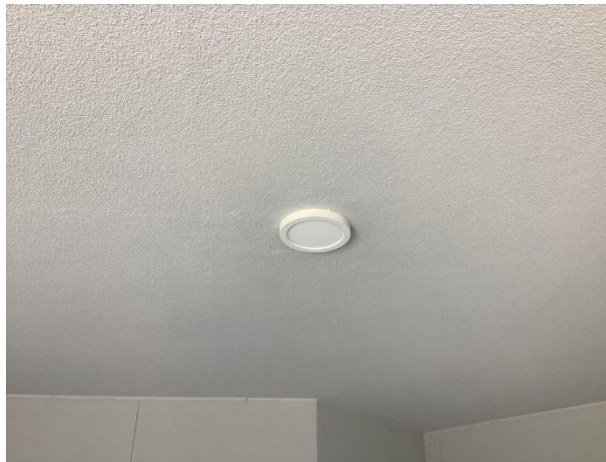
Condition: Good overall

Ceiling mounted light fixture

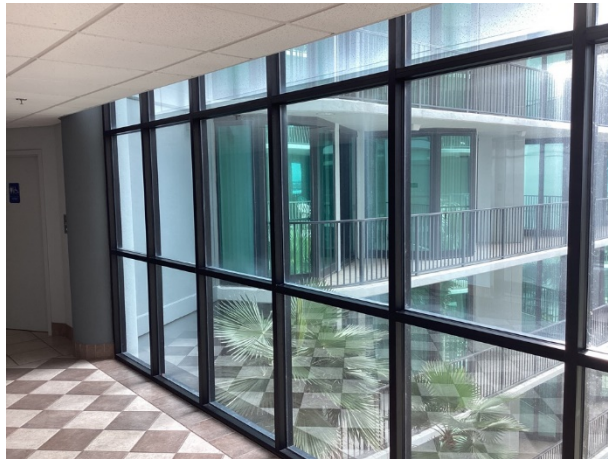
Condition: Good overall

Common windows

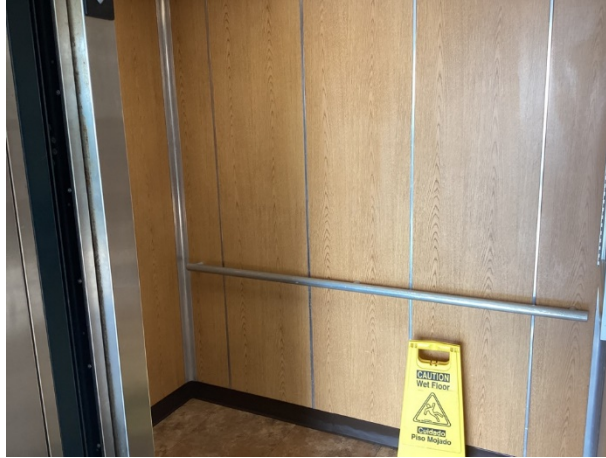
Condition: Good overall

Elevator cab finishes

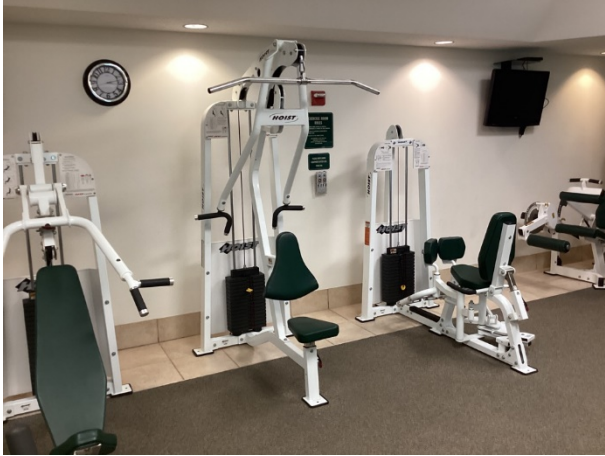
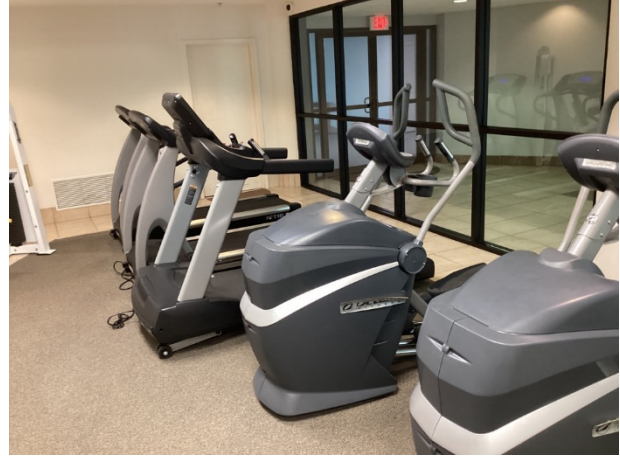
Conditions: Good overall

Strength training exercise equipment

Cardiovascular exercise equipment

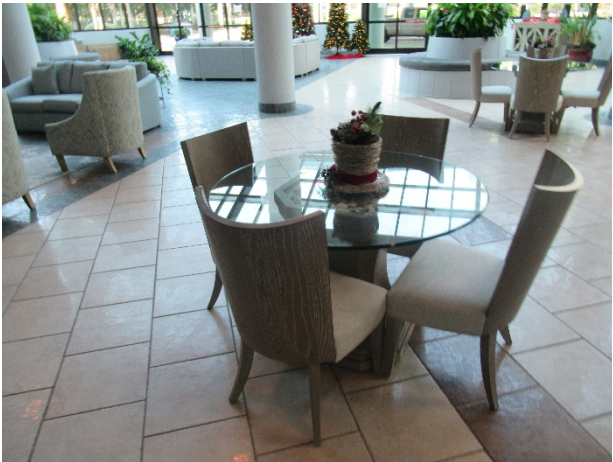
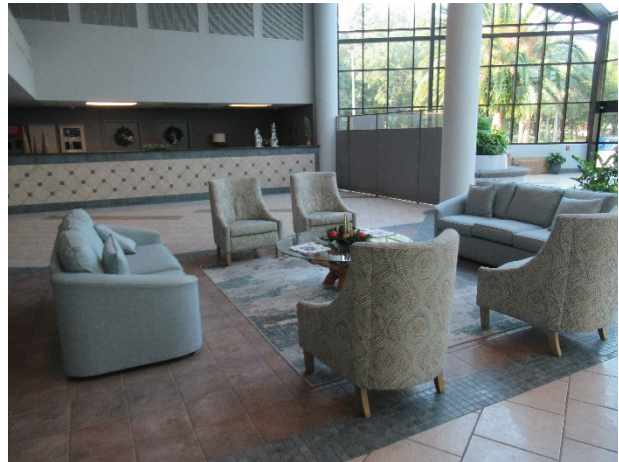
Condition: Good overall

Overview of furnishings

recommend the Association budget \$9,000 plus inflation for phased replacements of up to twenty-five percent (25%) of the furnishings per event.

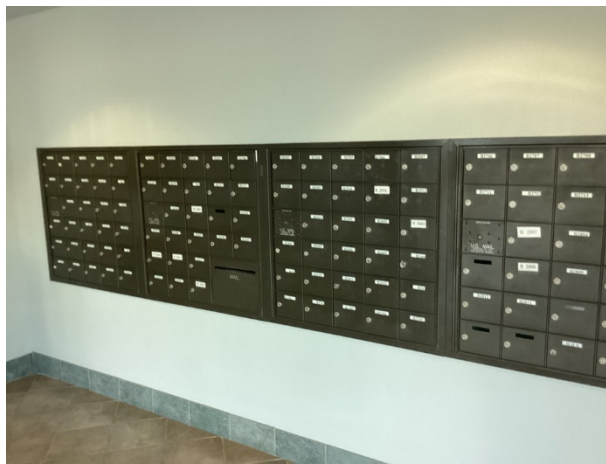
Mailboxes

Condition: Reported good overall

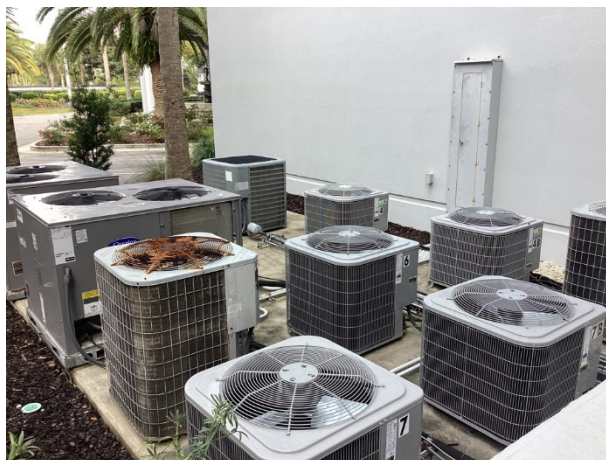
Condition: Reported satisfactory without operational deficiencies

Split system condensing unit

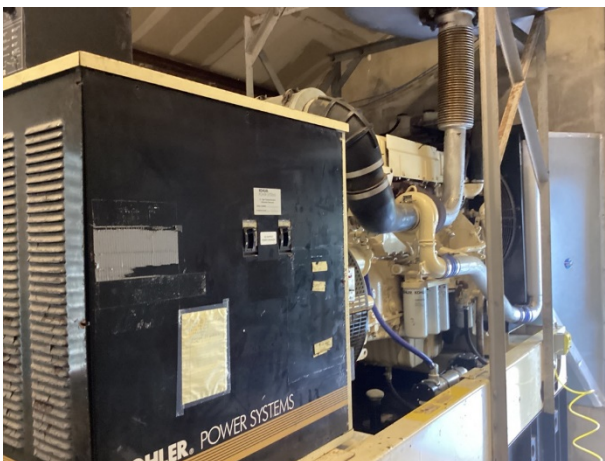
Generator

Condition: Reported satisfactory without operational deficiencies

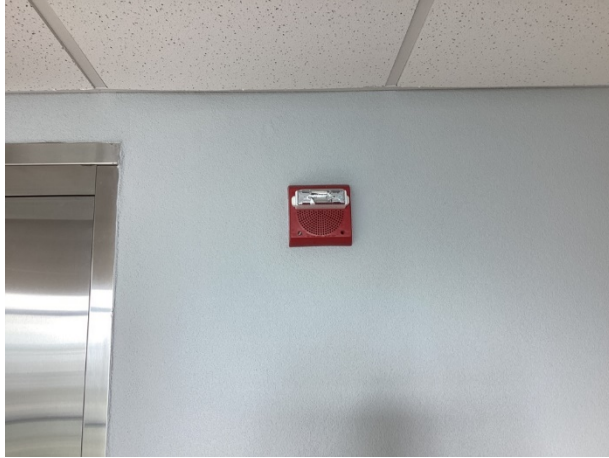
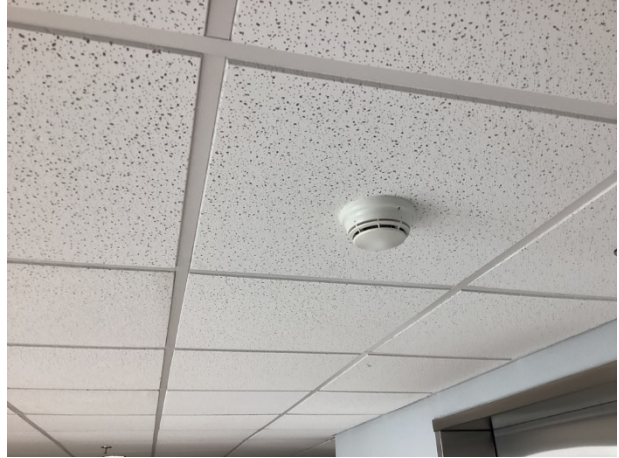
Conditions: Reported satisfactory without operational deficiencies.

Emergency devices

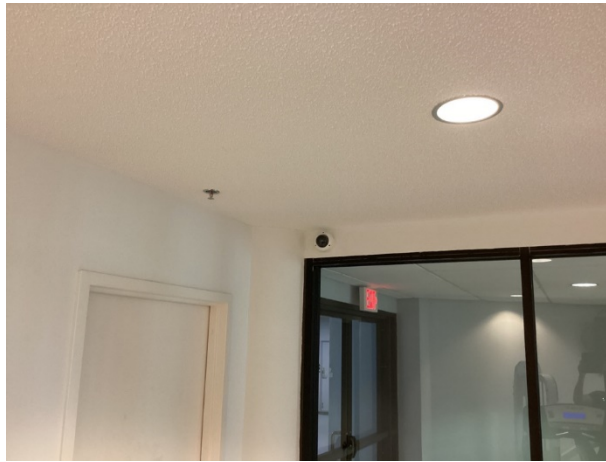
Condition: Reported satisfactory without operational deficiencies

Security system camera

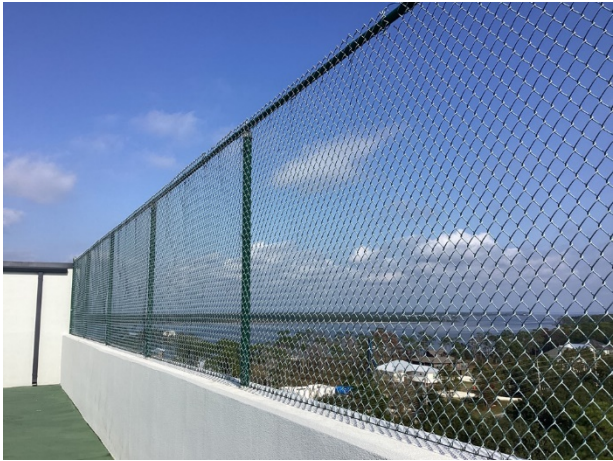
Condition: Good to fair overall with rust evident.

Chain link fence

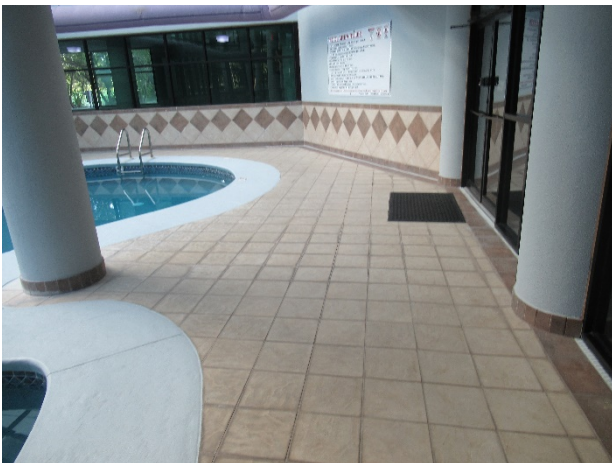
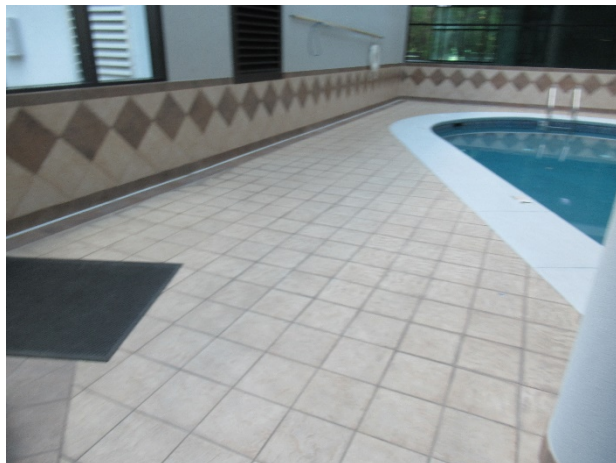
Condition: Good overall

Overview of indoor pool deck tile

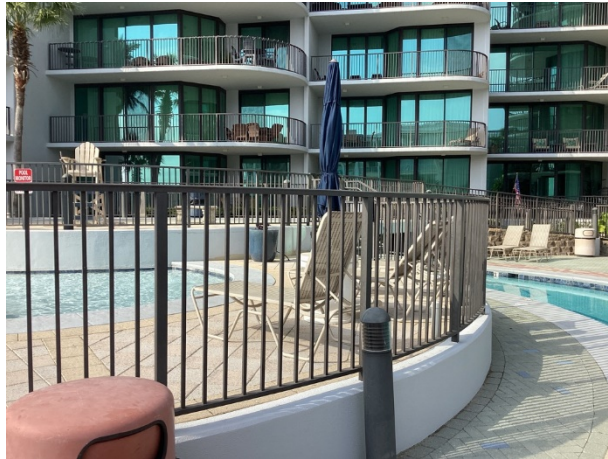
Condition: Good overall

Aluminum pool fence

- Annually:
 - Inspect and repair loose fasteners or sections, and damage
 - Repair leaning sections and clear vegetation from fence areas which could cause damage

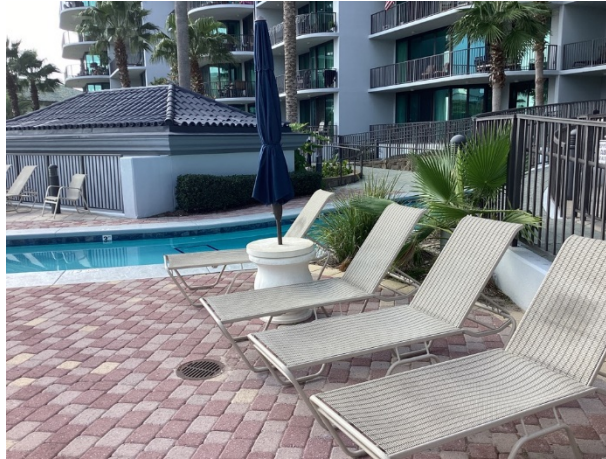
Condition: Good overall

Pool furniture

Expenditure Detail Notes: Expenditure timing and costs are depicted in the **Reserve Expenditures** table in Section 3. We recommend interim re-strapping, refinishing, cushion replacements, reupholstering and other repairs to the furniture as normal maintenance to maximize its useful life.

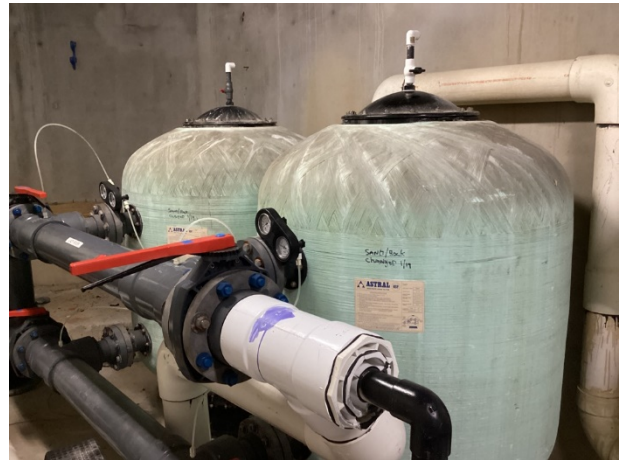
Condition: Reported satisfactory without operational deficiencies

Pool mechanical equipment

Pool filters

Pool mechanical equipment for fountains

Lazy river pump

Expenditure Detail Notes: Expenditure timing and costs are depicted in the **Reserve Expenditures** table in Section 3. Failure of the pool mechanical equipment as a single event is unlikely. Therefore, we include replacement of up to fifty percent (50%) of the equipment per event. We consider interim replacement of motors and minor repairs as normal maintenance.

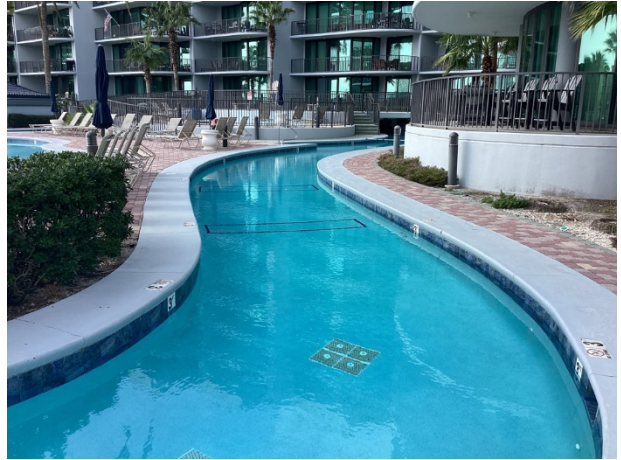
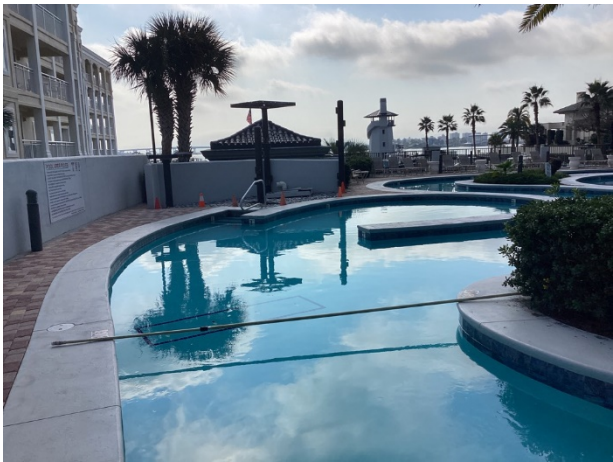
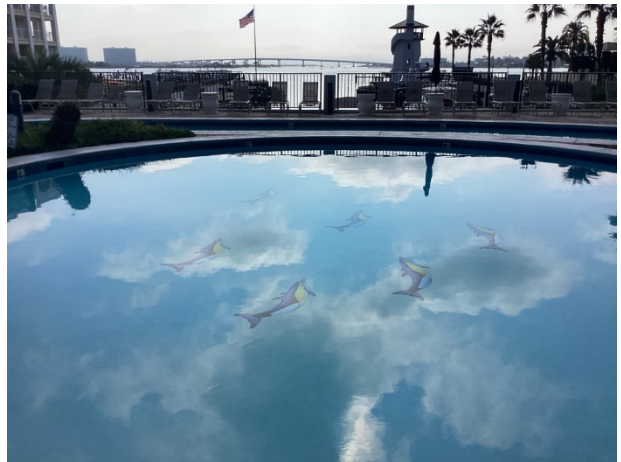
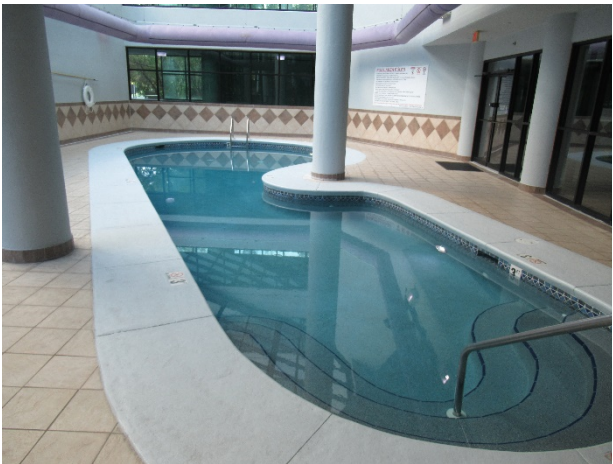
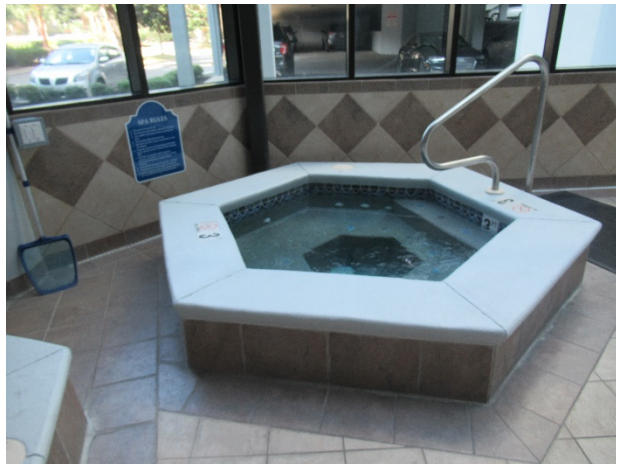
Condition: Good

Pool plaster overview

Lazy river plaster overview

Dolphin pool plaster overview

Overview of indoor pool

Overview of indoor spa

Expenditure Detail Notes: Expenditure timing and costs are depicted in the **Reserve Expenditures** table in Section 3. We recommend the Association budget for full tile replacement every other plaster replacement event. Removal and replacement of the finish provides the opportunity to inspect the pool structures and to allow for partial repairs of the underlying concrete surfaces as needed. To maintain the integrity of the pool structures, we recommend the Association budget for the following:

- Removal and replacement of the plaster finishes
- Partial replacements of the scuppers and coping as needed
- Replacement of tiles as needed
- Replacement of joint sealants as needed
- Concrete structure repairs as needed

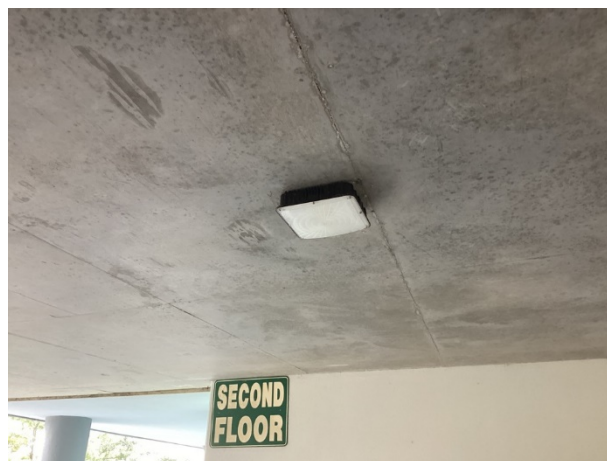
Condition: Reported satisfactory

Garage light fixture

- As-needed:
 - Inspect and replace/repair broken or dislodged fixtures
 - Replace burned out bulbs

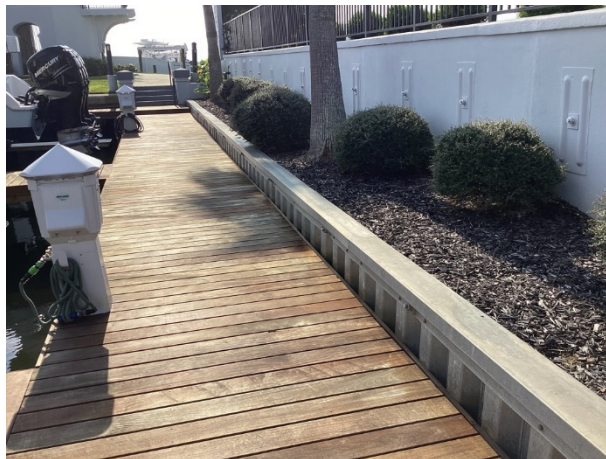
Conditions: Good overall

Steel bulkhead

Association and includes allowances for a complete inspection and partial replacement of up to twenty percent (20%) of the bulkheads.

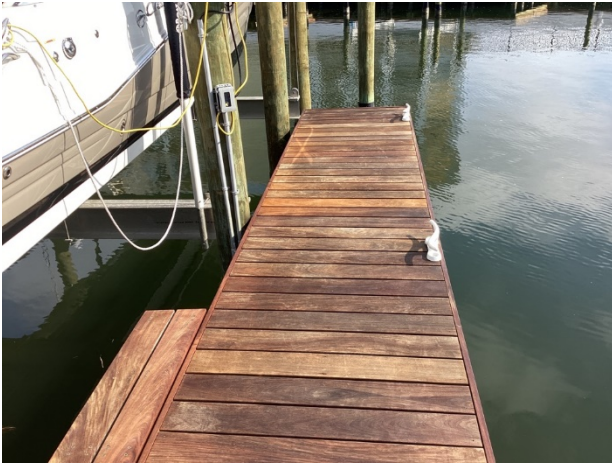
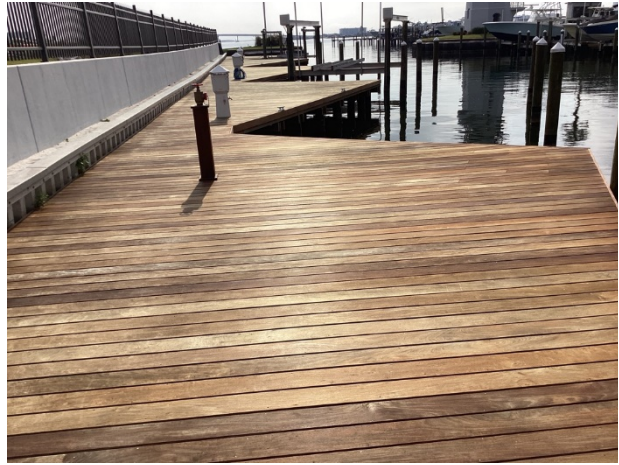
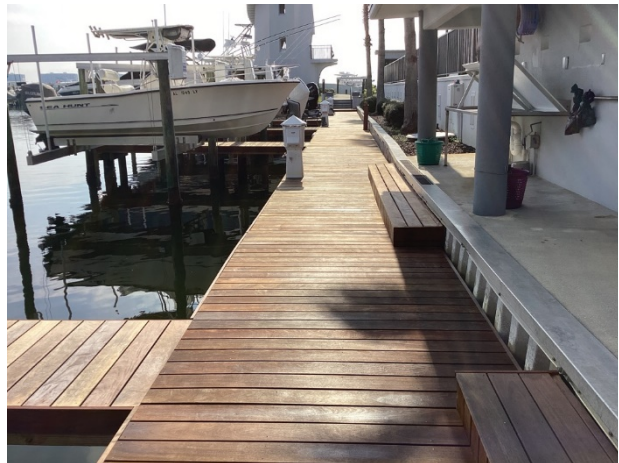
Condition: Good overall

Harbor deck boards

Harbor docks

Overview of wood pilings

Dock with composite decking

Expenditure Detail Notes: Expenditure timing and costs are depicted in the **Reserve Expenditures** table in Section 3. Our cost is based on information provided by the Association. Our cost for repairs includes allowances for complete replacement of the decking and partial replacement of up to ten percent (10%) of the structure and pilings. Our estimate of cost includes an allowance for removal and disposal of the existing docks, and installation of new docks and utility lines. Phoenix On The Bay II should fund interim replacements of utilities prior to replacement of the docks and annual repairs to displaced pilings through the operating budget.

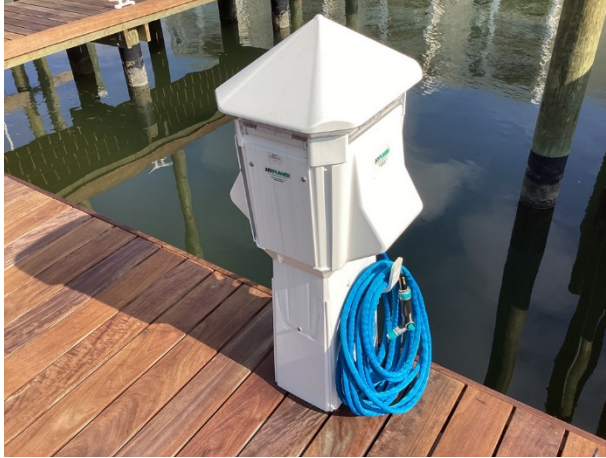
Condition: Reported satisfactory

Power pedestals
